Pre-Purchase Inspection Report

123 Smith Street, Smithville, 6000

Details of a Pre Purchase Building and Timber Pest Inspection

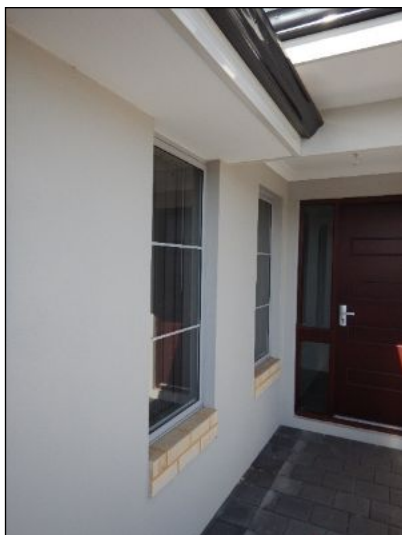
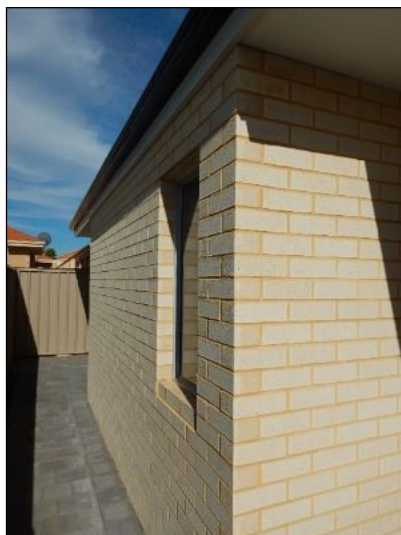
- The external brick wall are in a functional and satisfactory condition at time of inspection.
- The external wall render is in a functional and satisfactory condition at time of inspection.

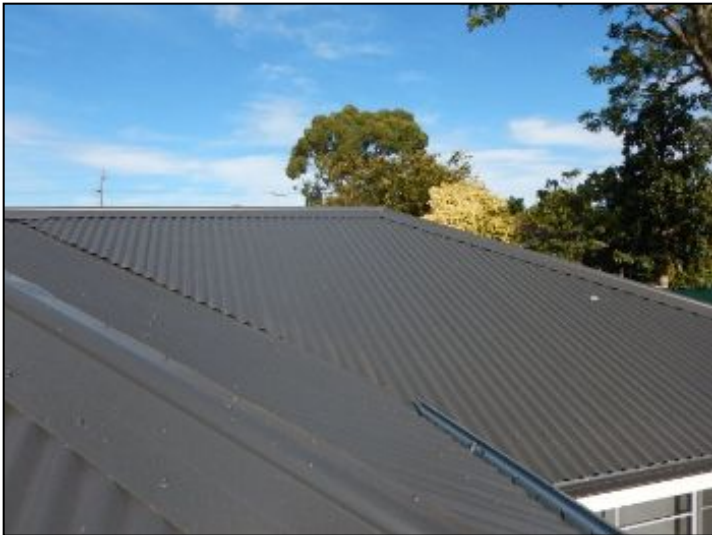
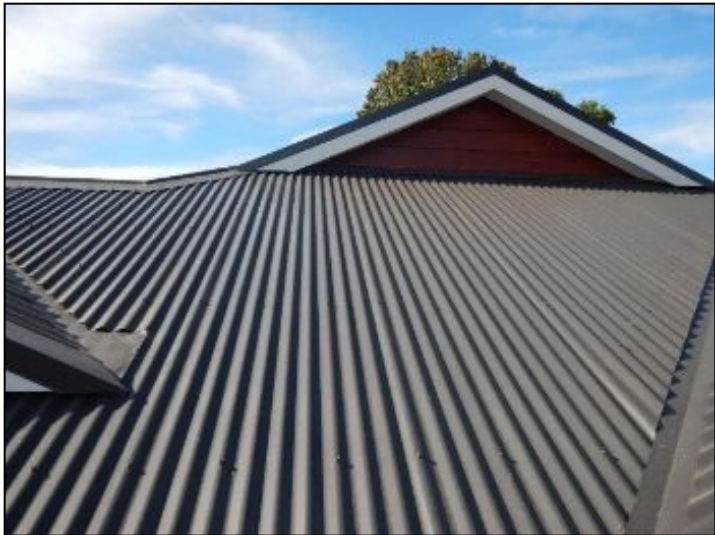
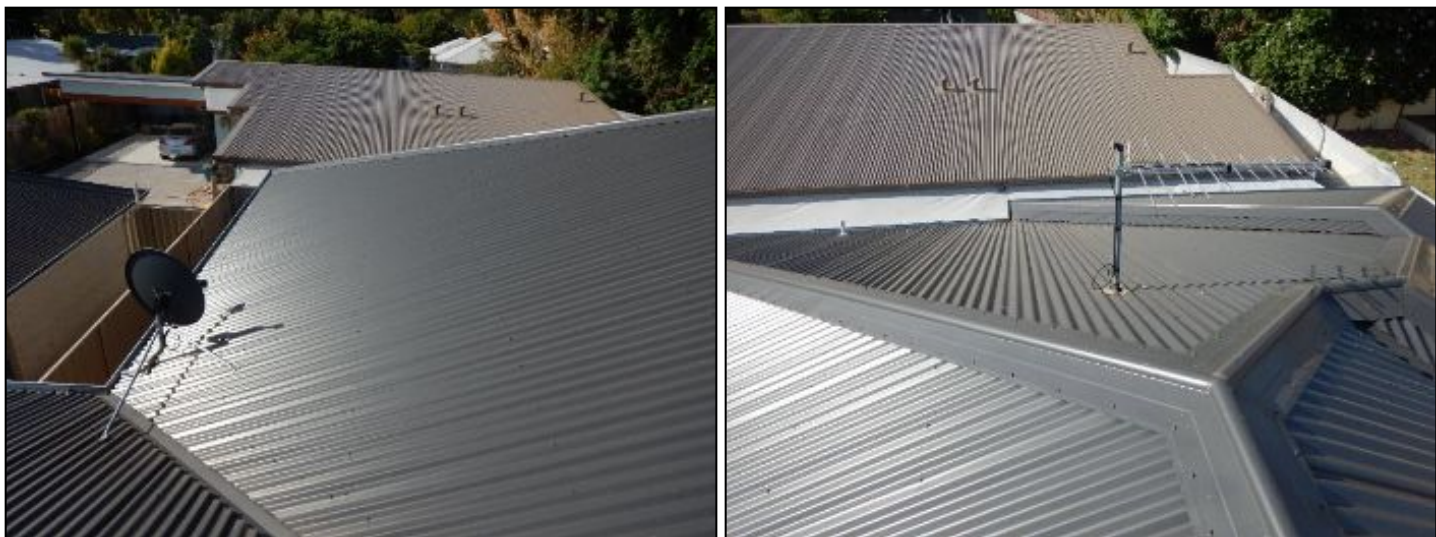
- The metal roofing material appear functional and in a satisfactory condition at the time of inspection.

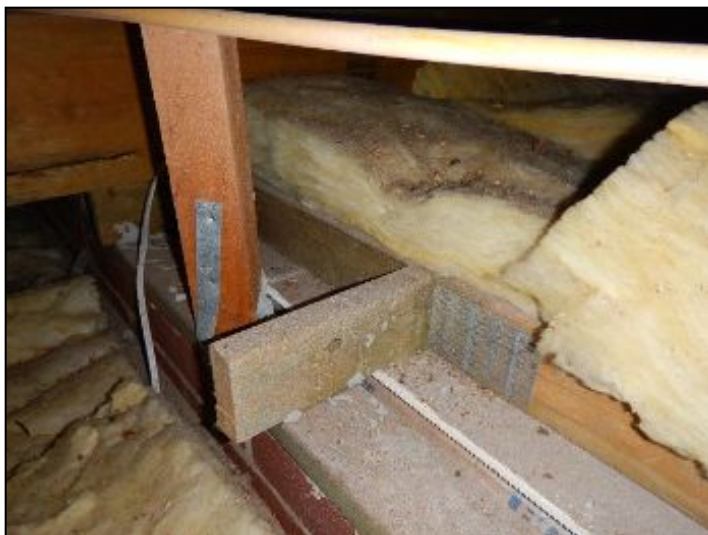
- Due to the placement of insulation on the top of the ceilings it is not possible to fully inspect the condition of the ceiling structure and supports. Inspection was limited and based on what was visually accessible at the time of the inspection.
- Limited review due to insulation installed between the rafters.

- The visible ceiling structure appears functional and in a satisfactory condition at time of inspection.

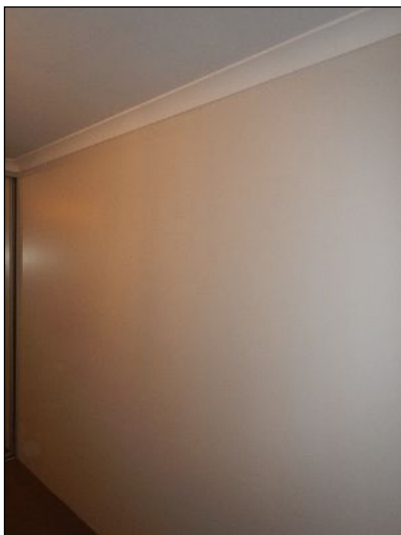
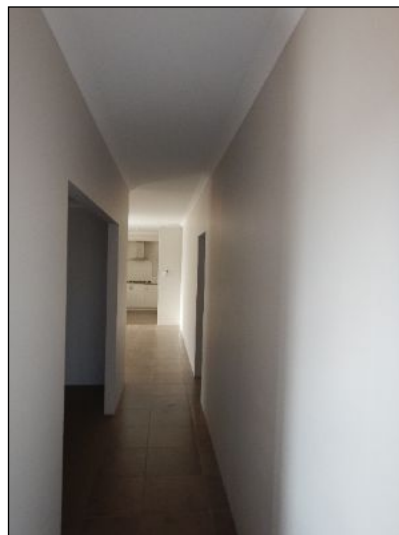
- Minor shrinkage cracks in the wall plaster in some locations. This is not a structural issue and can be repaired normally.
- The shower wall adjacent to the bathroom and ensuite were tested with a moisture meter. No indication of moisture was presence.

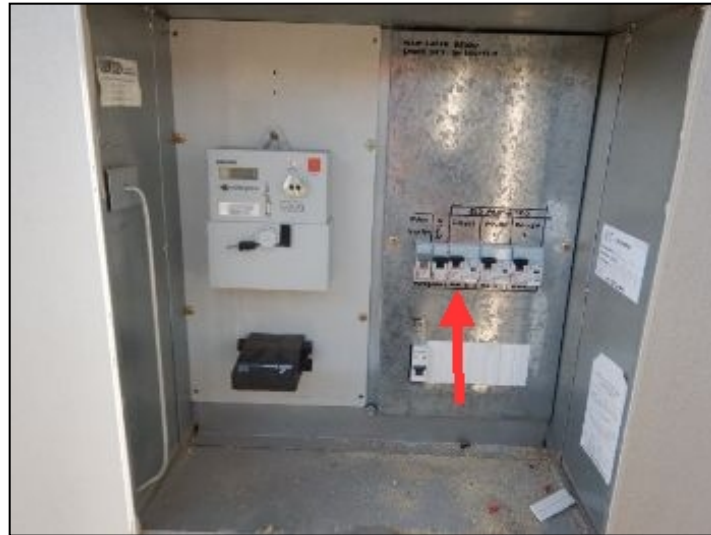
Electrical		
Page 14 Item: 1	Electrical Panel	<ul style="list-style-type: none"> • There are at least 2 RCD's installed which protect both the power point and light circuits. However the power point RCD failed to reset. In line with the latest regulations all RCD safety switch are required to be operational prior to settlement. This is required to be carried out by the vendors.

• There are at least 2 RCD's installed which protect both the power point and light circuits. However the power point RCD failed to reset. In line with the latest regulations all RCD safety switch are required to be operational prior to settlement. This is required to be carried out by the vendors.

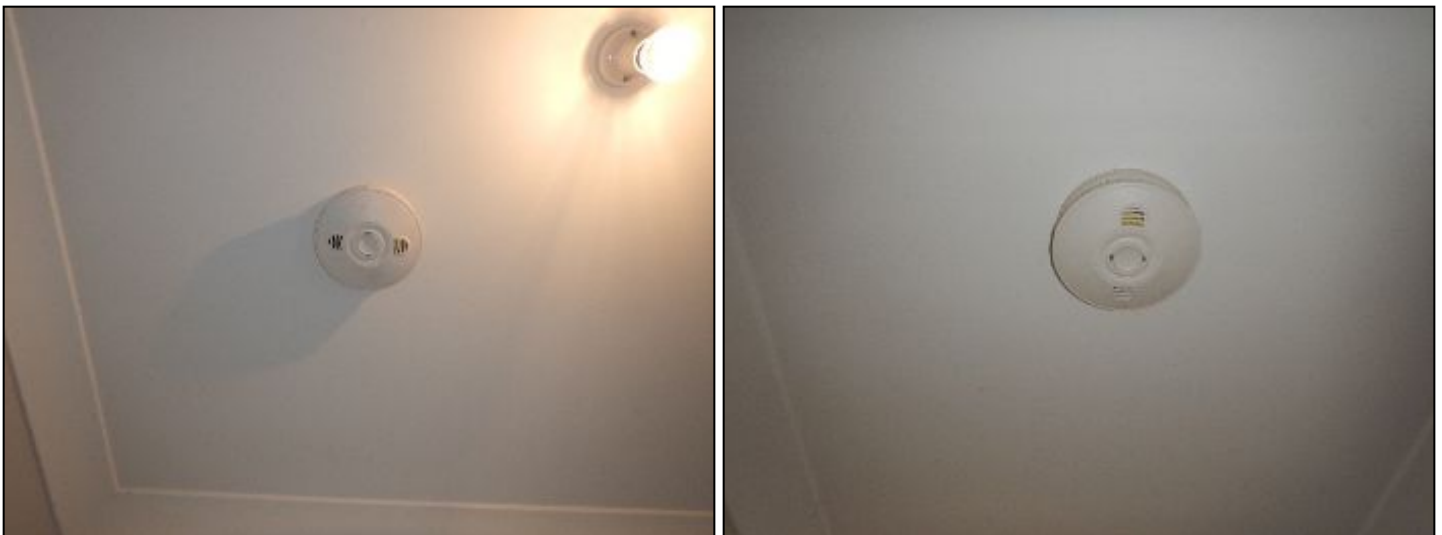
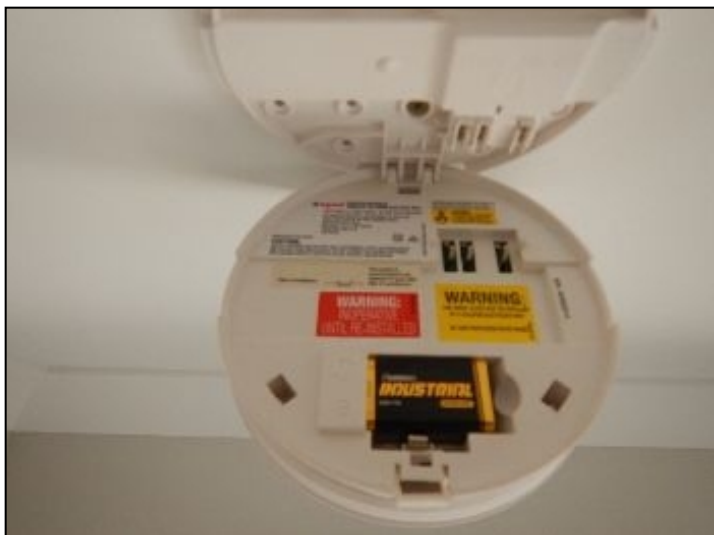
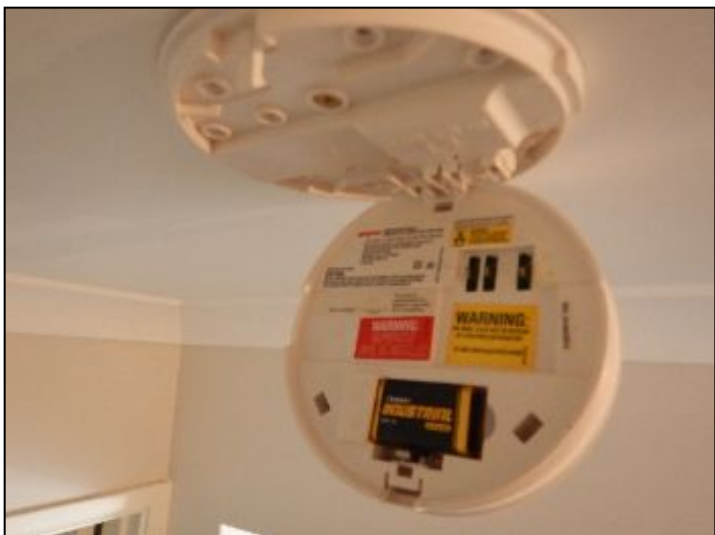
- There are 2 hard wired smoke alarms that are installed in the bedroom hallway areas.
- Smoke alarms are due for replacement in 2025.

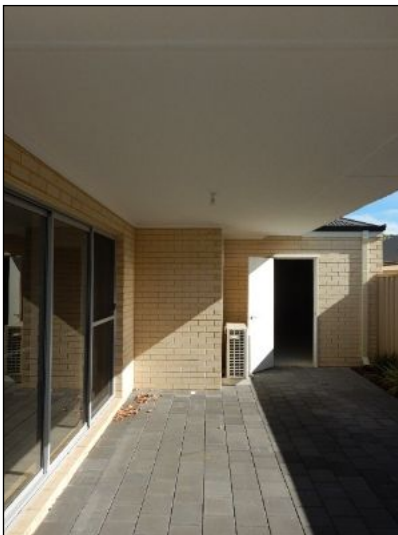
The patio/porch is part of the main structure and appears functional and in a satisfactory condition at time of inspection.

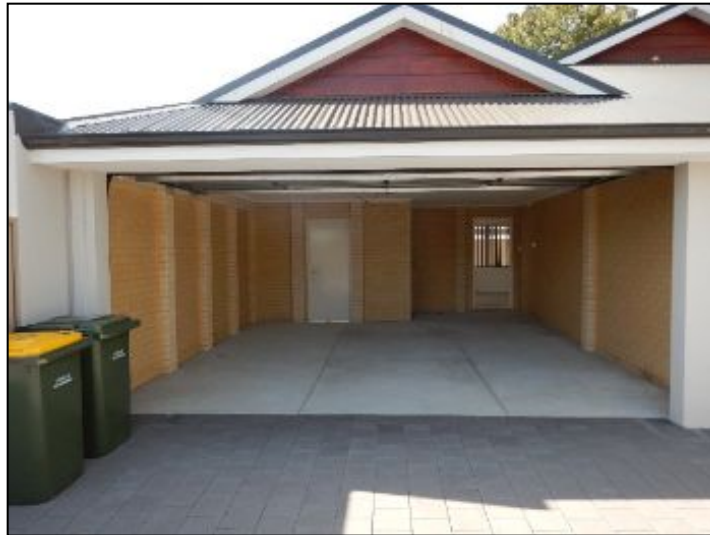
• Garage is part of the main structure and appears functional and in a satisfactory condition at time of inspection.

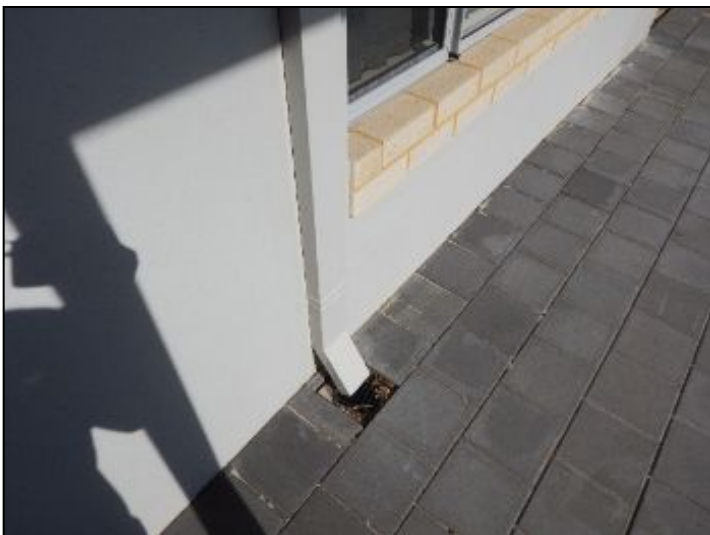
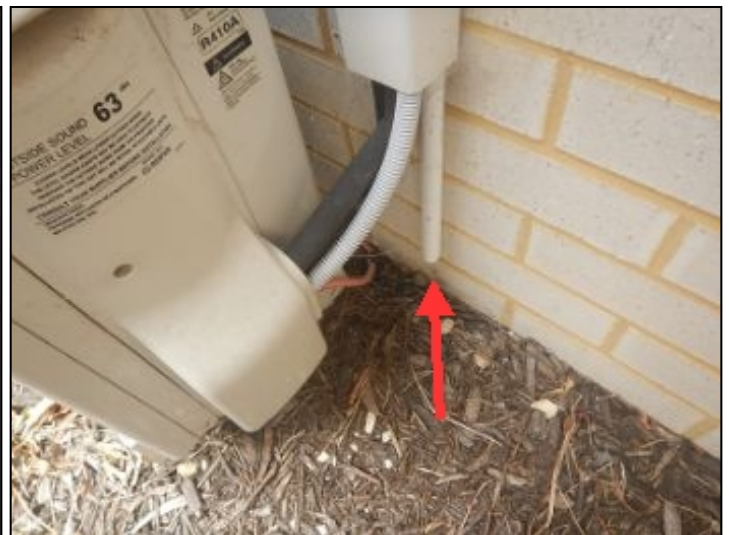
- Roof drainage conditions within 3 metres of the house appeared satisfactory.
- The air conditioner discharge pipe discharges on the foundations. This should ideally be directed into the stormwater, or at least 3 metres away from the building.

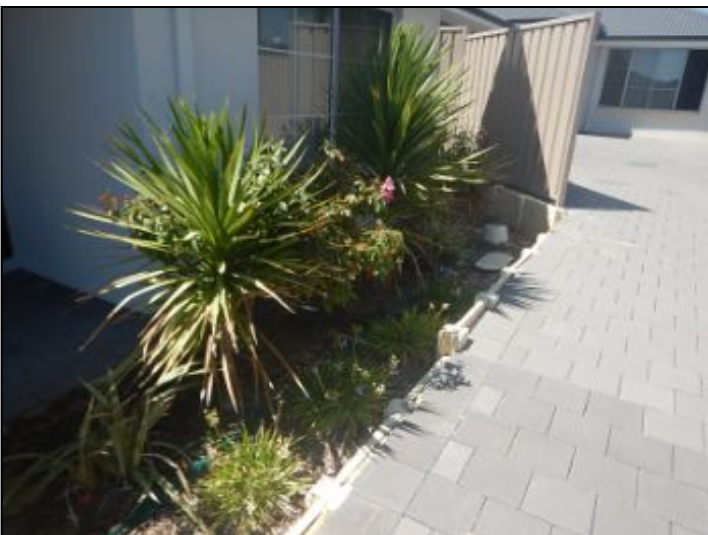
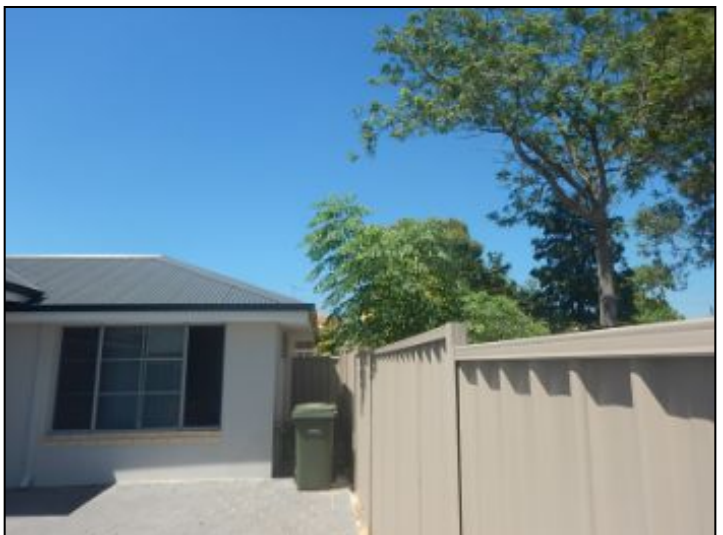
There is vegetation in contact with the ground and the property which may allow termite bridging over any existing termite barrier. Recommend pruning all vegetation in contact with the property.

- Remove any garden beds abutting the home to eliminate excessive moisture.
- Prune or remove any plants that are in contact or proximity to home to eliminate pathways of wood destroying insects.
- Tree limbs within 3 m of roof should be trimmed away to provide air and sunlight to roof, while minimizing debris & dampness.

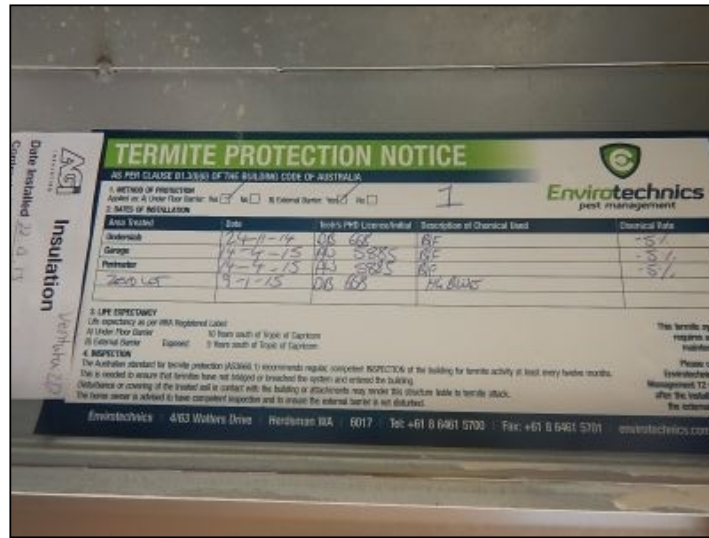
- It appears that the last termite treatment to the property was undertaken in 2015.
- It appears that the last termite inspection to the property was undertaken in 2016.
- Termite inspections should be undertaken every 12 months.
