Pre-Purchase Inspection Report

InspectionSmith
Property Inspections

123 Smith Street, Smithville, 6000

Date of Inspection: 29/5/2018 Time: 9:00am
Weather: Fine

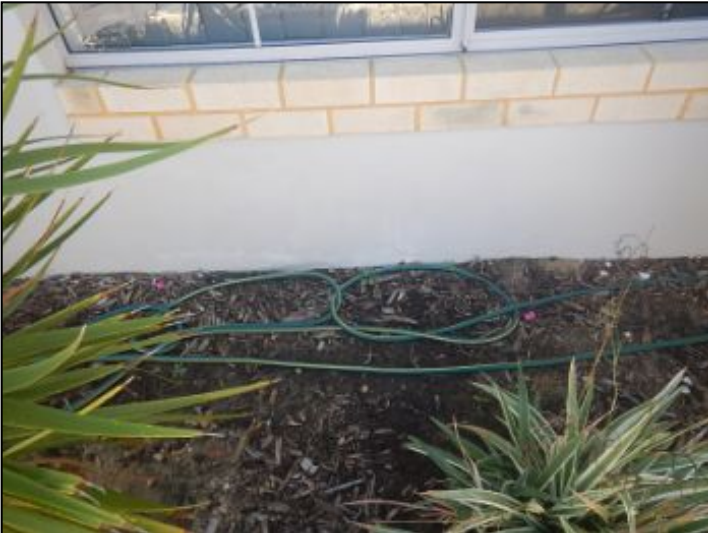
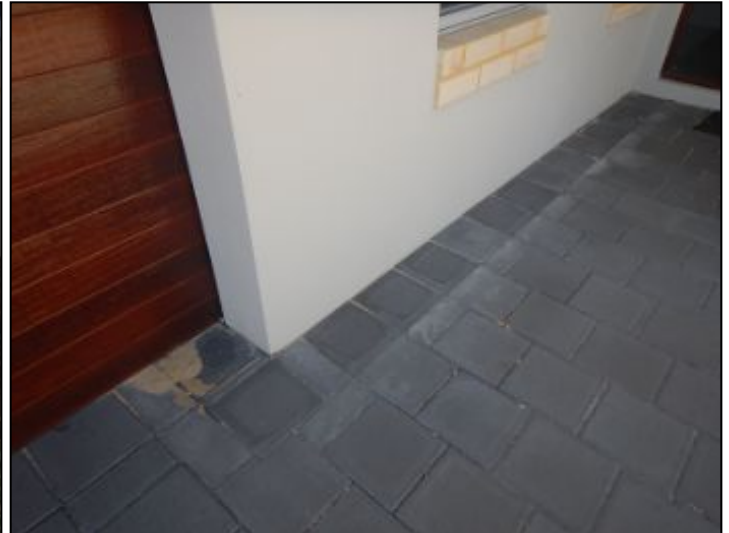
- Concrete slab appears functional and in a satisfactory condition at time of inspection.
- Slab edges are covered by soil and paving. This may allow termite entry into the walls. Slab edges should be cleared of soil and paving.

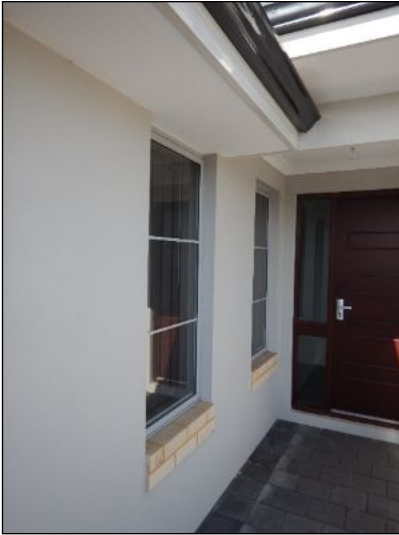
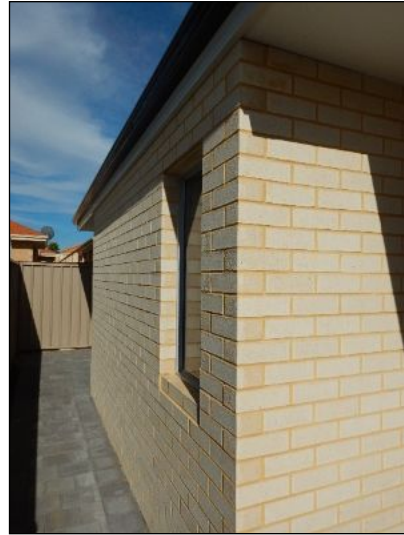
- The external brick wall are in a functional and satisfactory condition at time of inspection.
- The external wall render is in a functional and satisfactory condition at time of inspection.

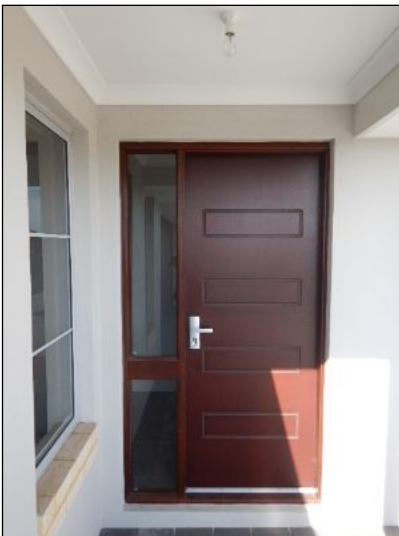
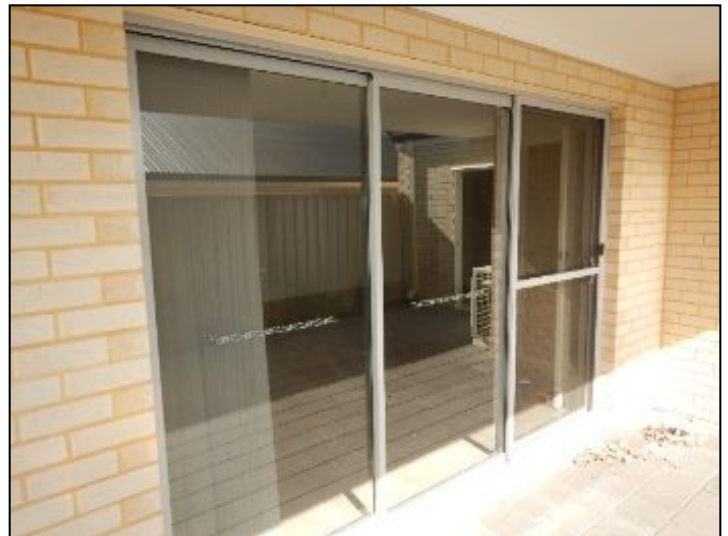
- Exterior doors are functional and in a satisfactory condition at time of inspection.

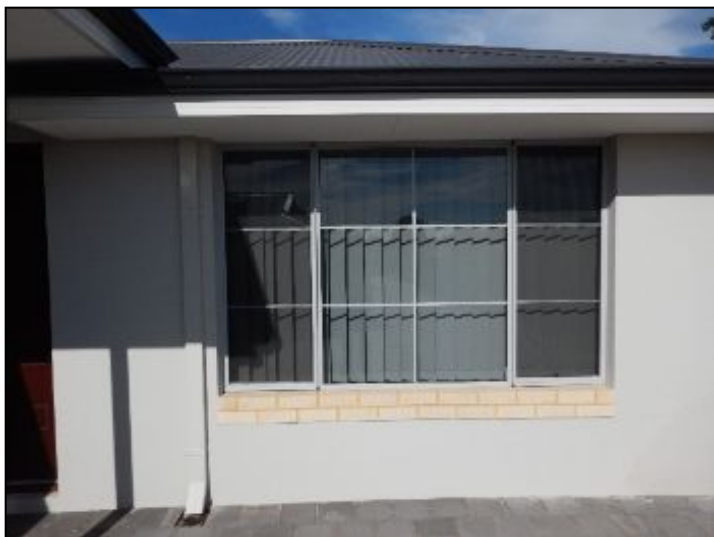
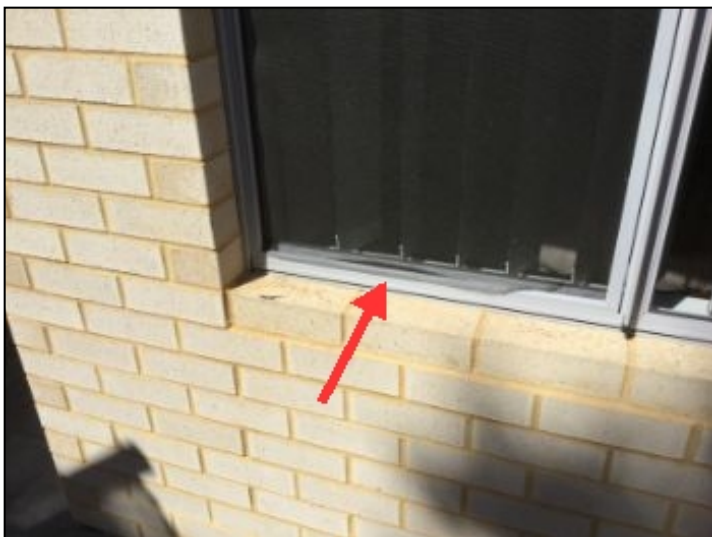
- Aluminium windows frames noted.
- External window components appear functional and in a satisfactory condition at time of inspection.
- Damaged fly screens observed.

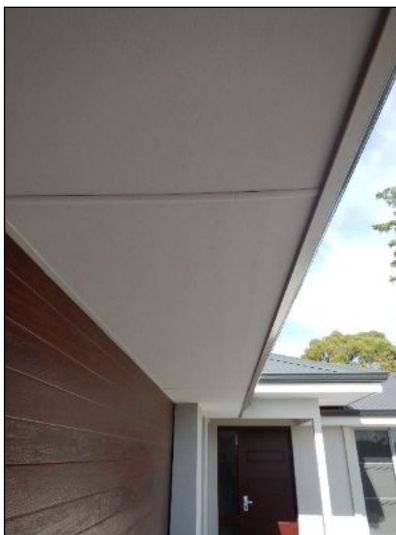
- Composition cement cladding ("Hardi-Board" etc.) eaves noted.
- Components appear functional and in a satisfactory condition at time of inspection.

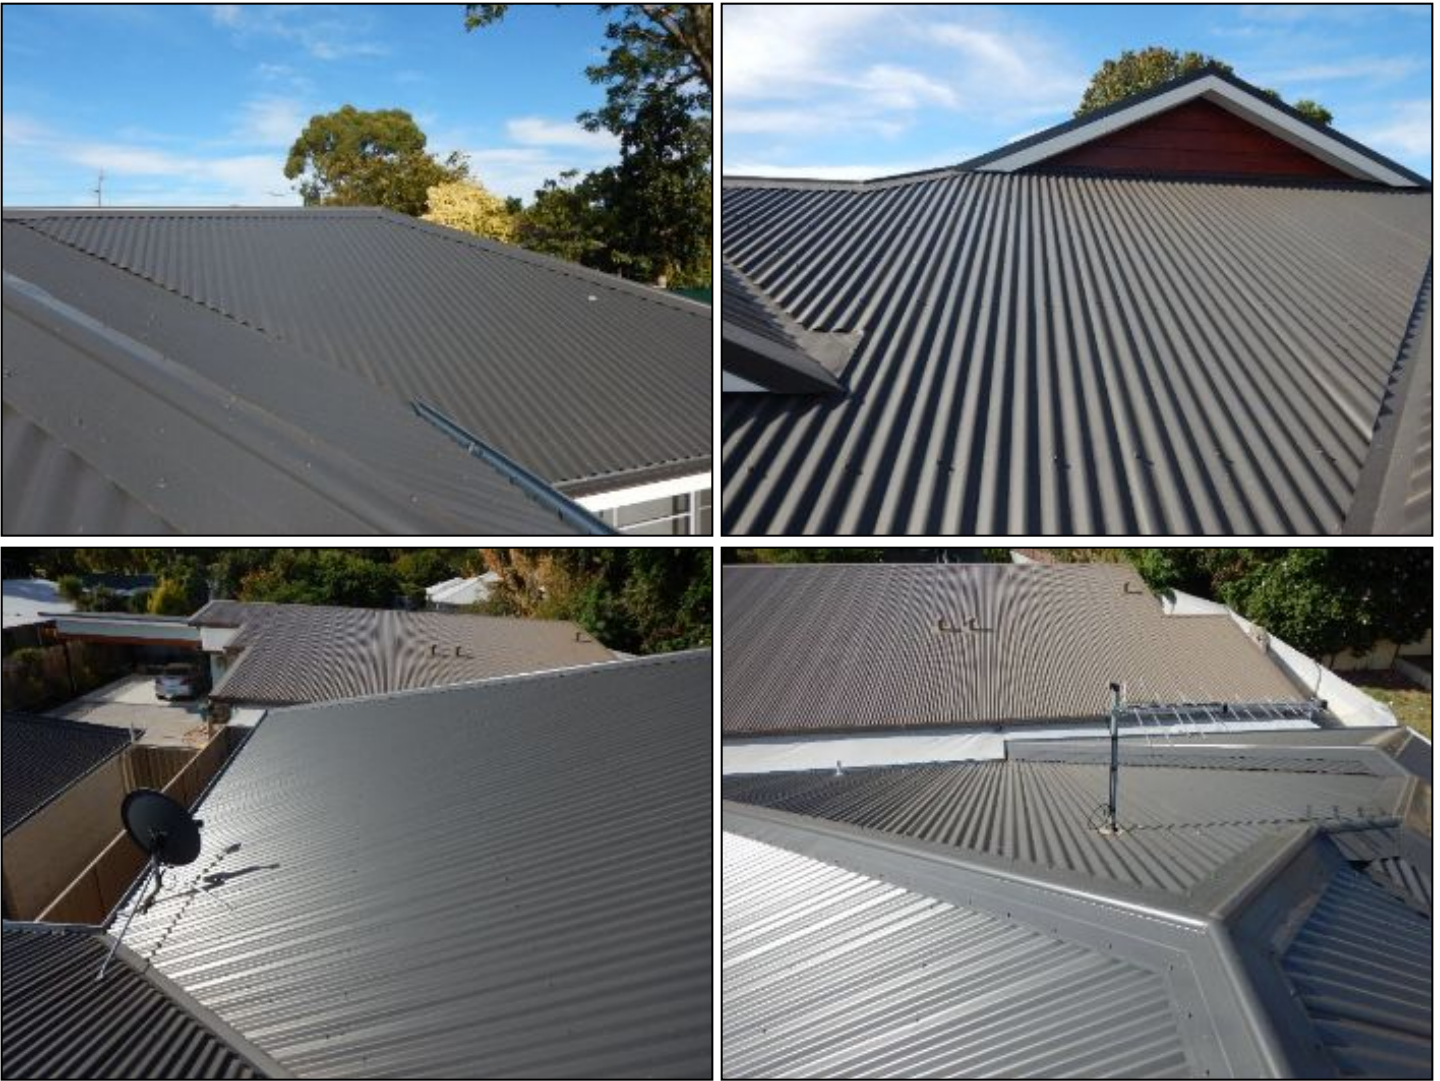
- The metal roofing material appear functional and in a satisfactory condition at the time of inspection.

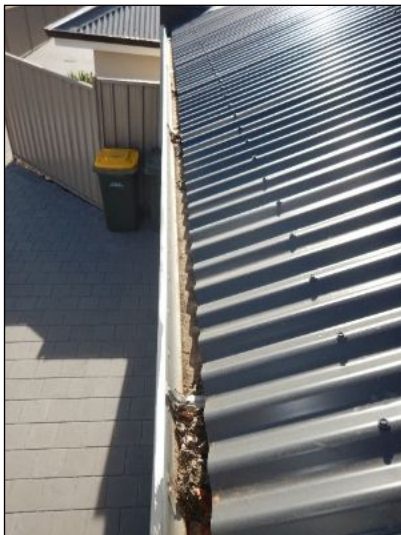
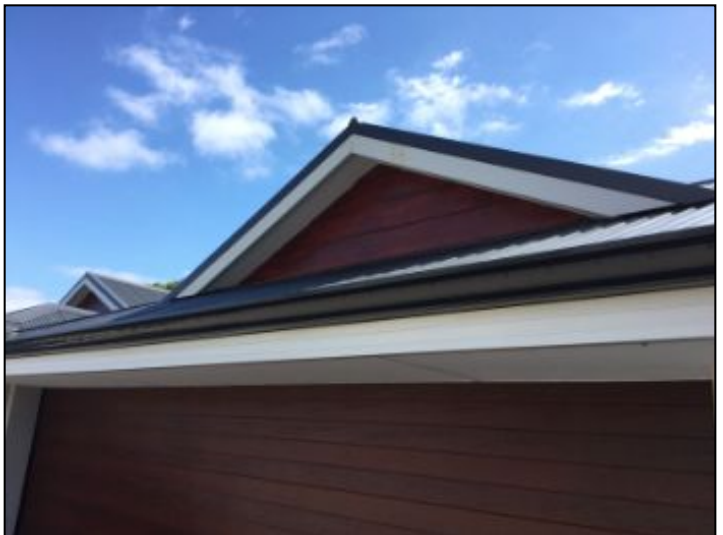
- The gutters appear functional and in a satisfactory condition at the time of inspection.
- The gutters should be regularly cleared of debris to ensure the proper flow of water from the roof.

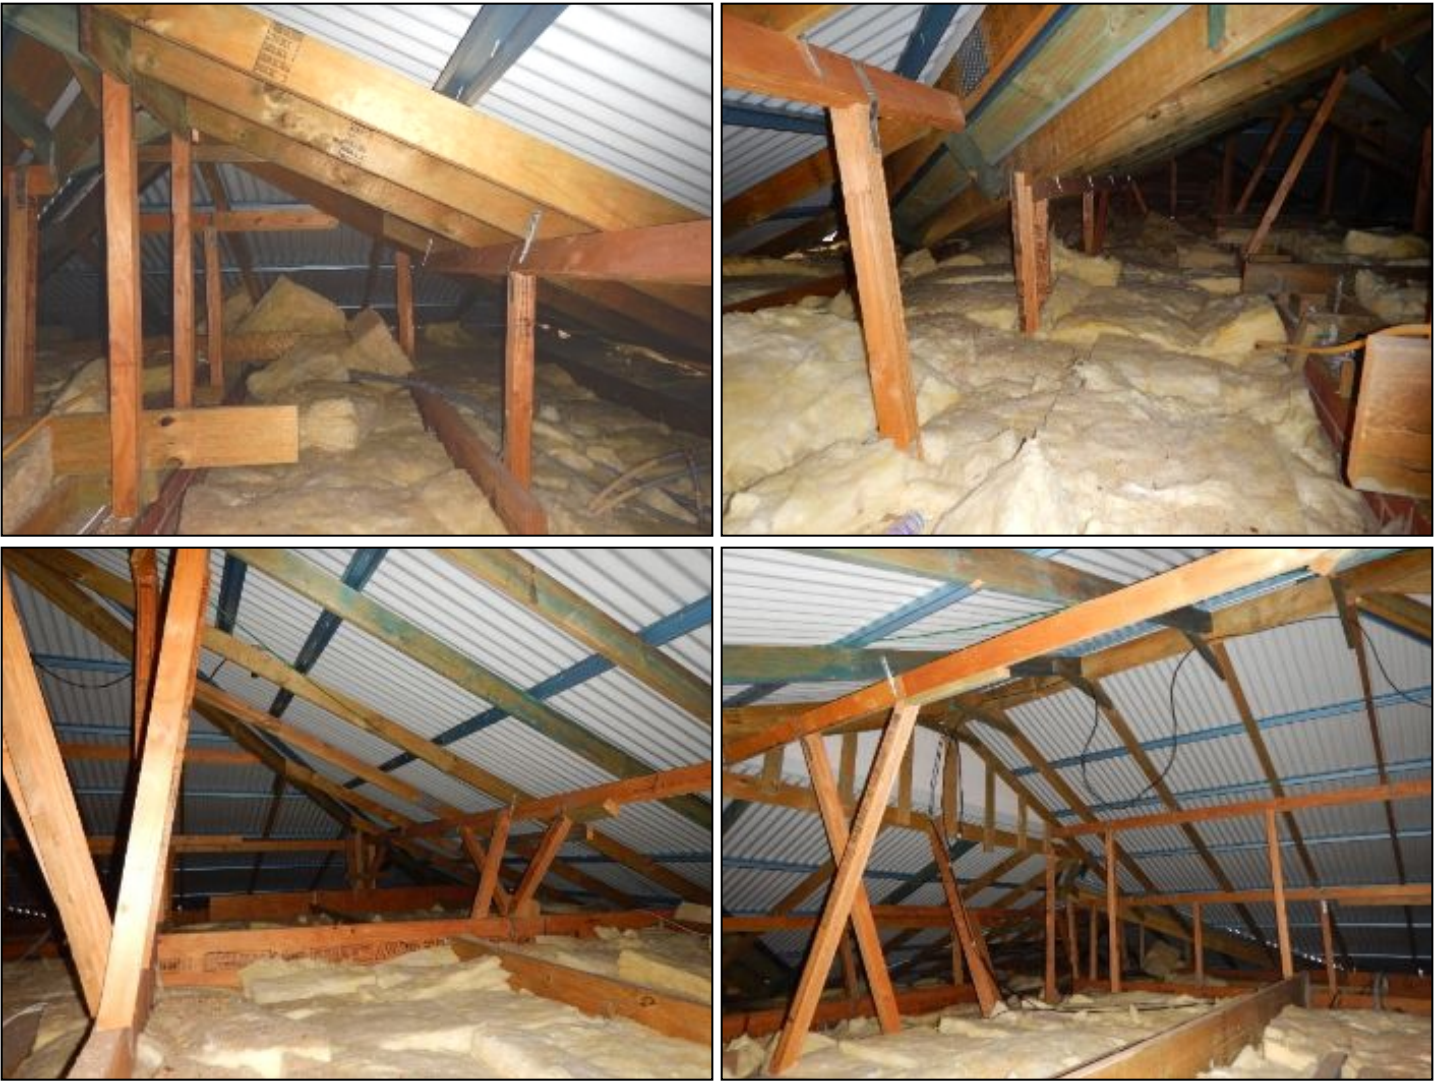
- The timber framed structure appears functional and in a satisfactory condition at time of inspection.

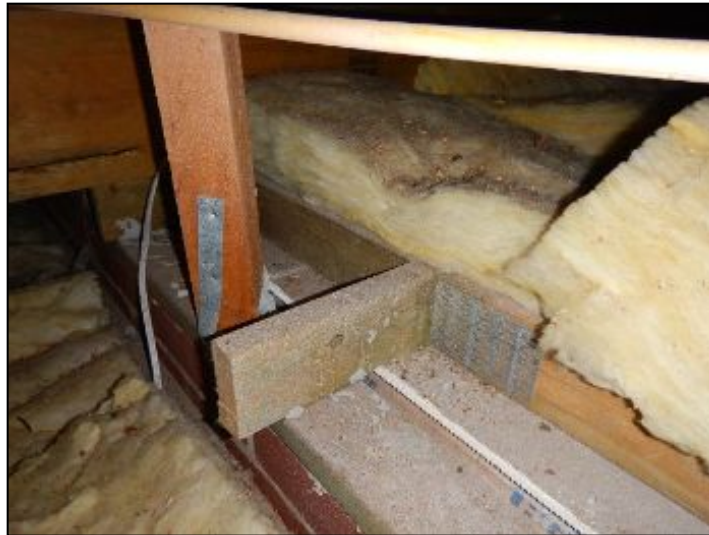
- The visible ceiling structure appears functional and in a satisfactory condition at time of inspection.

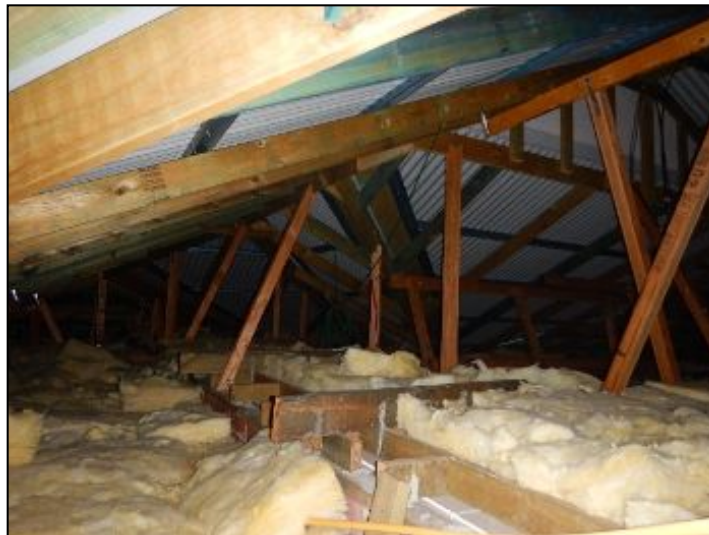
- Insulation appears functional and in a satisfactory condition at time of inspection.

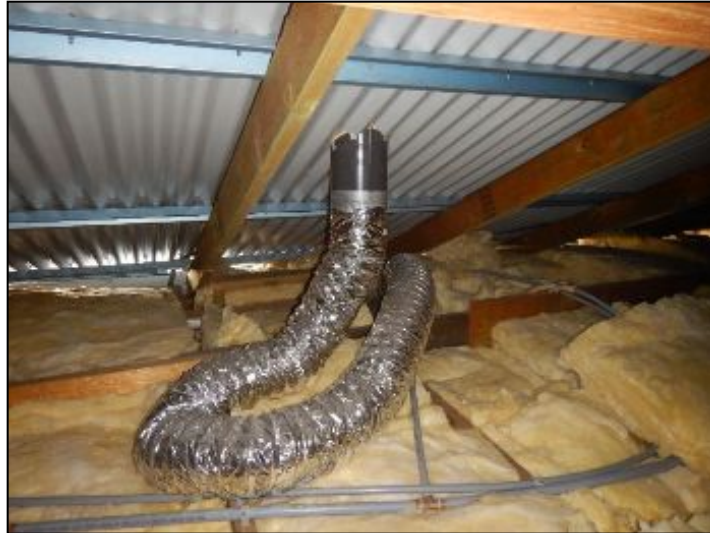
- Exhaust fan ducting appears functional and in a satisfactory condition at time of inspection.

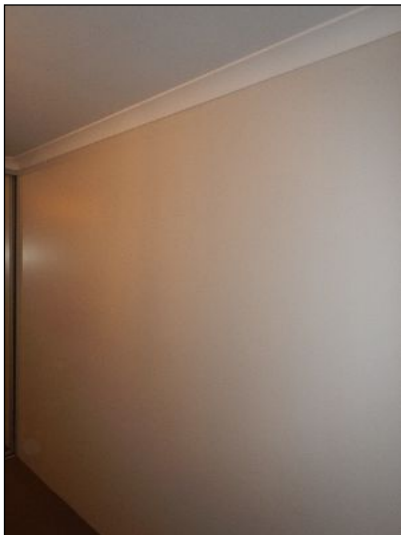
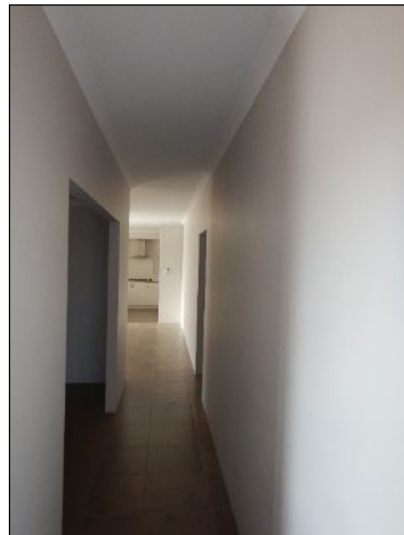
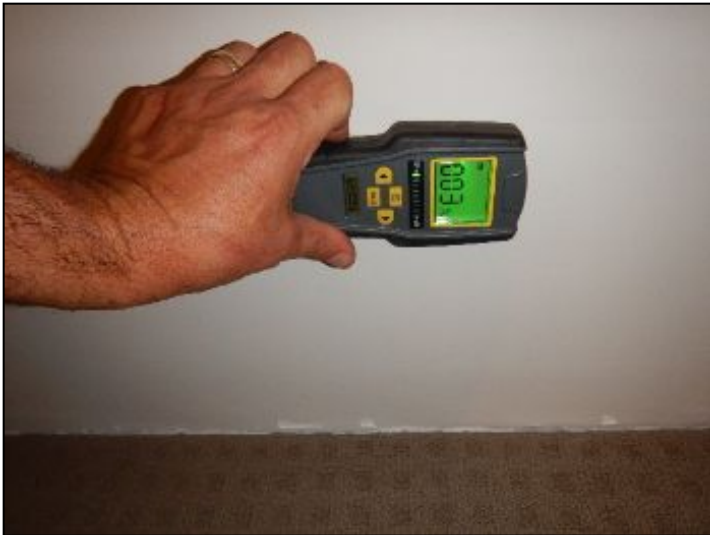
- Minor shrinkage cracks in the wall plaster in some locations. This is not a structural issue and can be repaired normally.
- The shower wall adjacent to the bathroom and ensuite were tested with a moisture meter. No indication of moisture was presence.

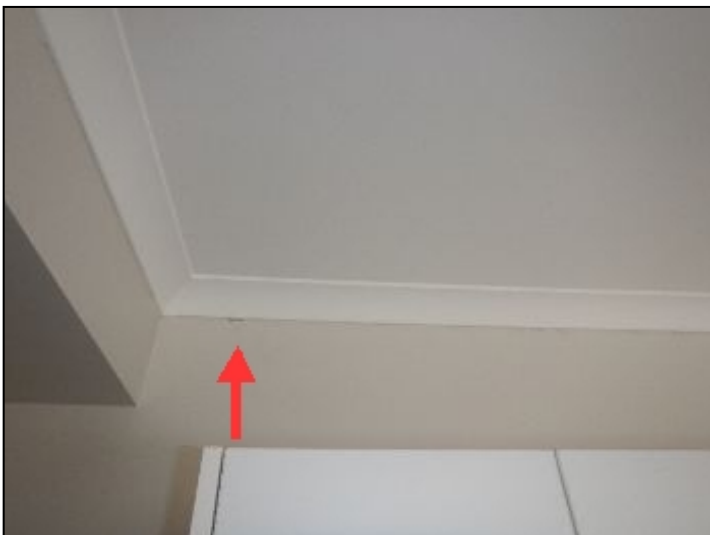
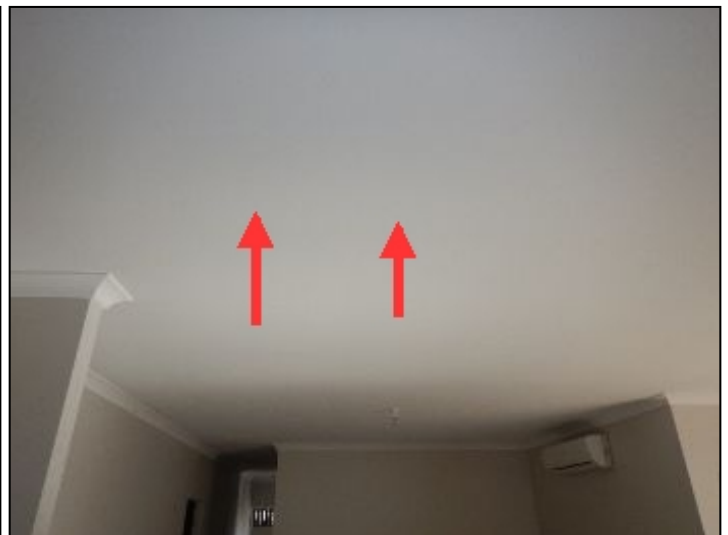
- There is minor damage on the cornice and some cracking which has occurred at the interface between the ceiling cornice and the wall at various locations. This can be a result of foundation settlement and/or movement in the roof structure. This does not appear to have affected the structural integrity of the home and can be repaired normally.
- There are minor stains noted on the ceiling. The area was tested with a moisture meter. No indication of moisture was present at the time of inspection.

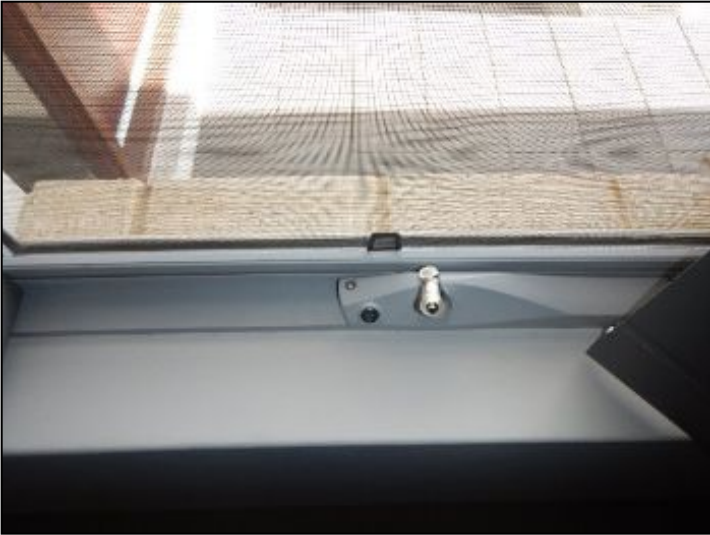
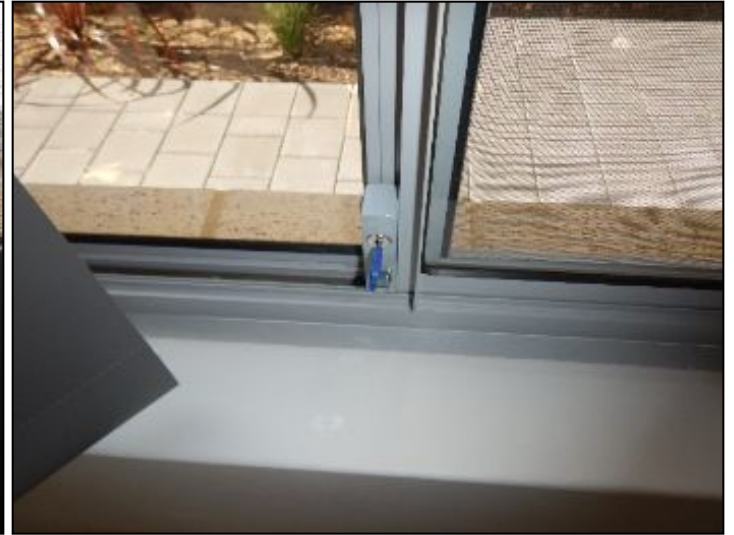
- Some windows were locked at the time of inspection. Recommend testing prior to settlement.

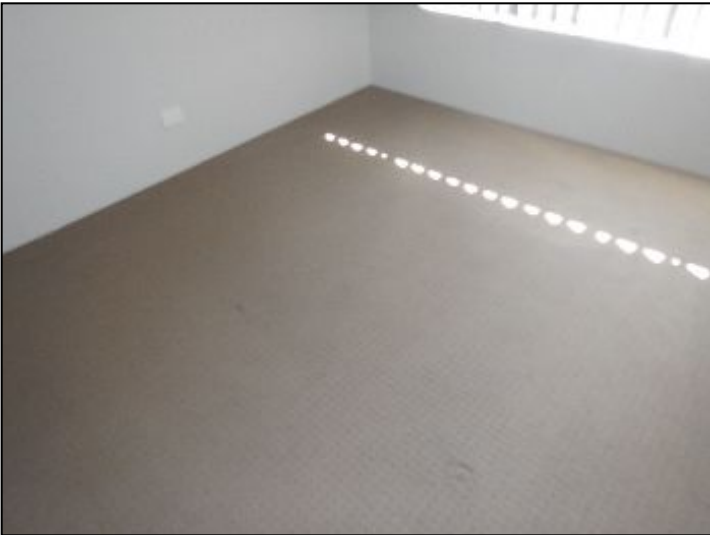
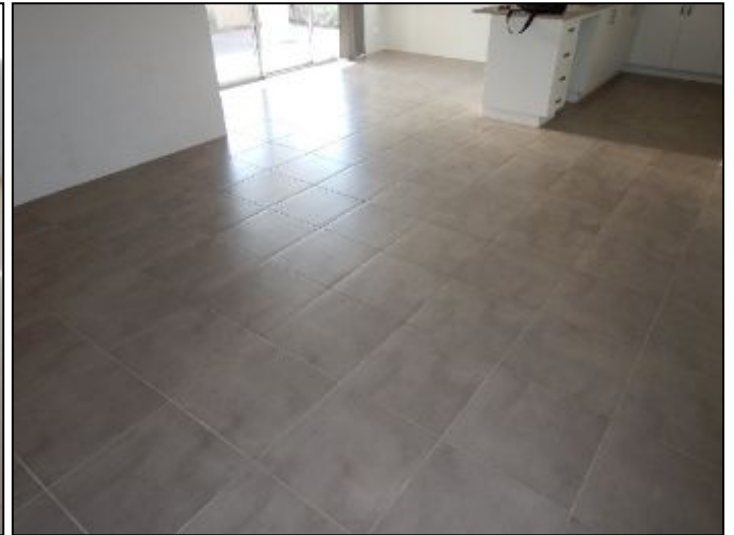
- Carpeted floors appear in a satisfactory condition at time of inspection.
- Tiled floors appear in a satisfactory condition at time of inspection.

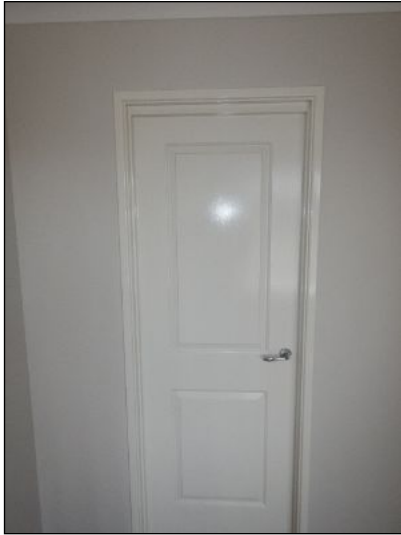
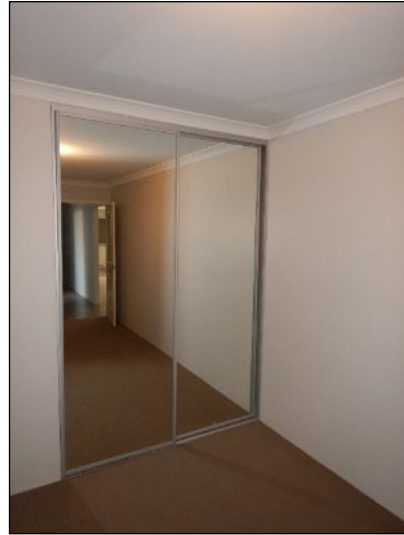
- The internal doors are in a satisfactory condition at time of inspection.

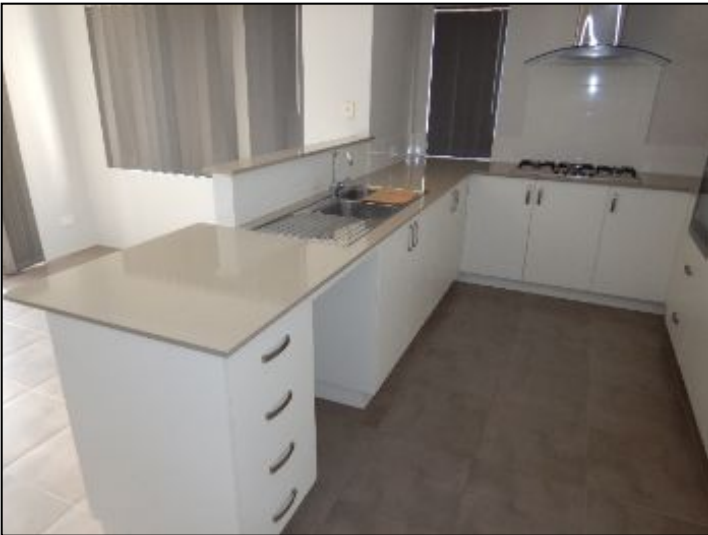
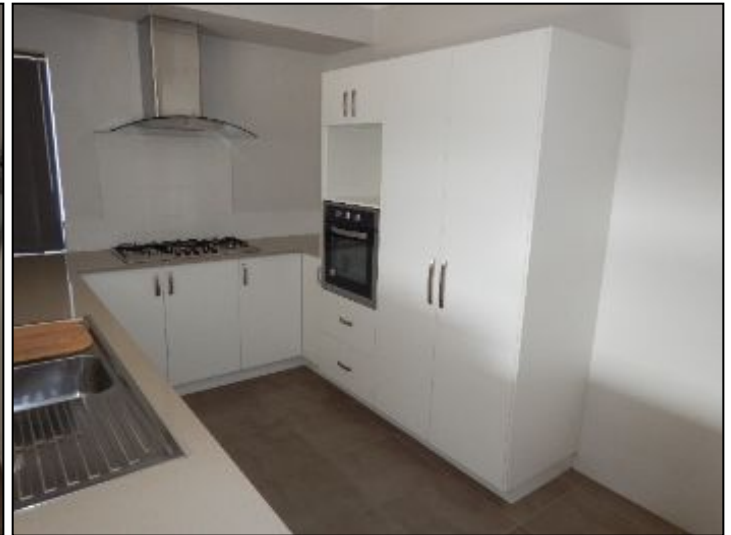
- The kitchen cabinets appear functional and in a satisfactory condition, at time of inspection.
- The kitchen bench tops appear functional and in a satisfactory condition, at time of inspection.

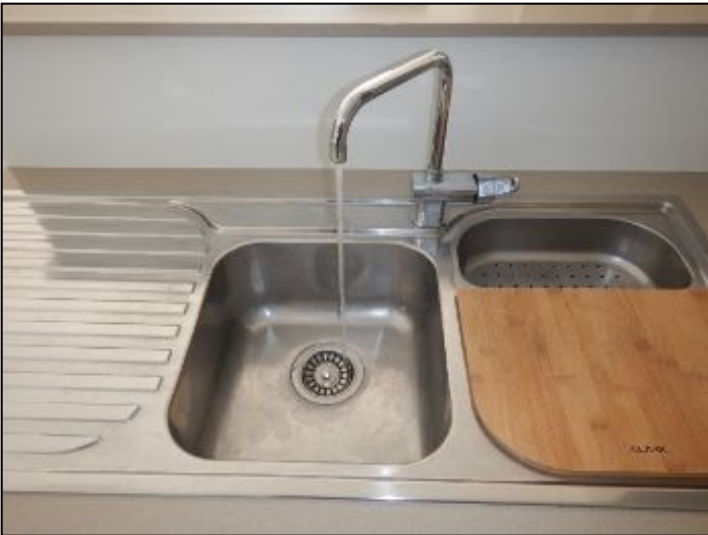
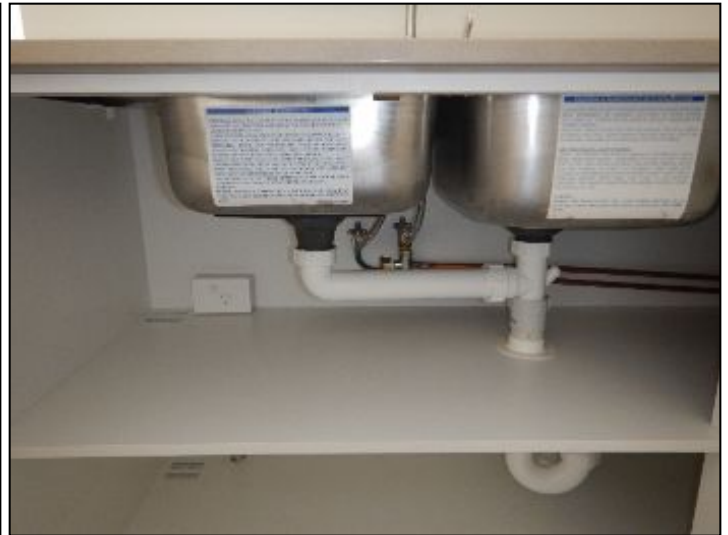
- The sink and related components are functional and in a satisfactory condition at time of inspection.
- Kitchen sink plumbing appeared in a functional and a satisfactory condition at time of inspection. No leak observed at the time of inspection.

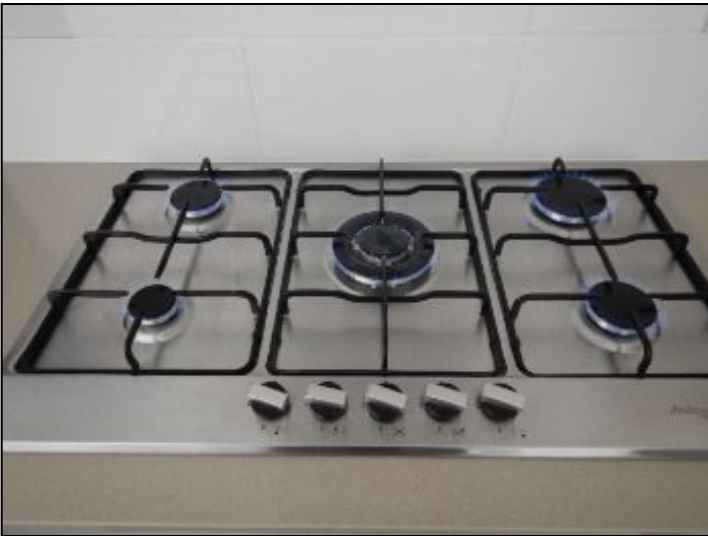
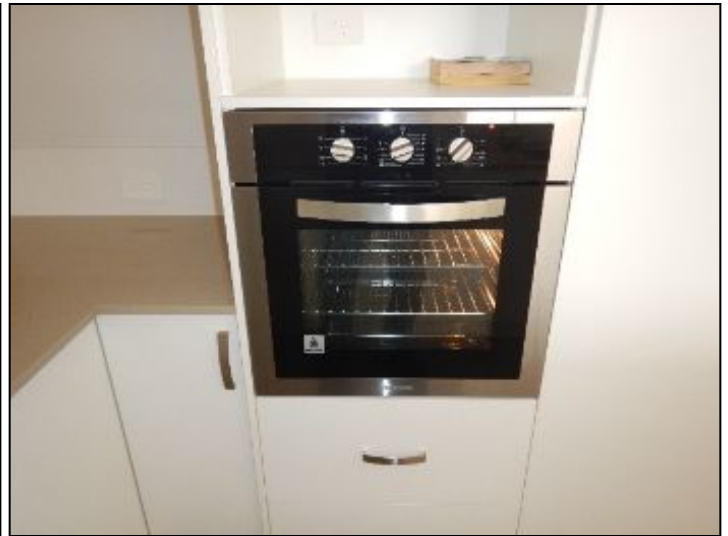
- No warranties or guarantees of this or any other appliance can be offered.
- Gas cook top noted and operated normally when tested. Unit appeared in a satisfactory at time of inspection.
- Electric oven noted and operated normally when tested. Unit appeared in a satisfactory at time of inspection.

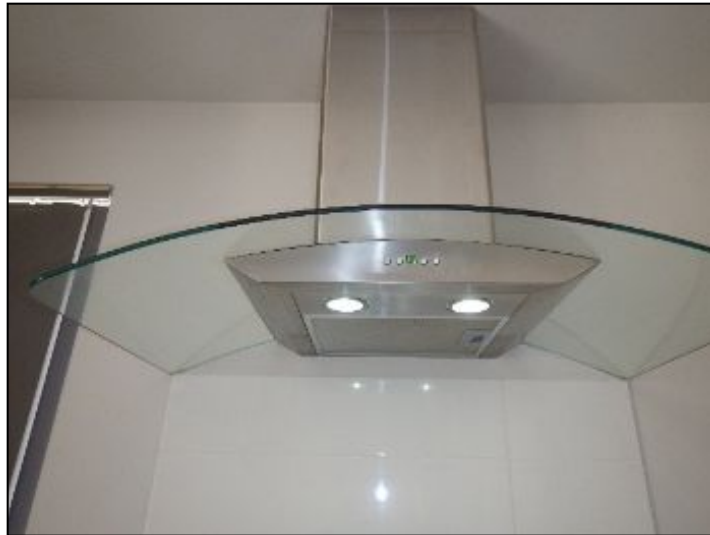
- The range hood was tested and appeared in a functional and in a satisfactory at time of inspection.

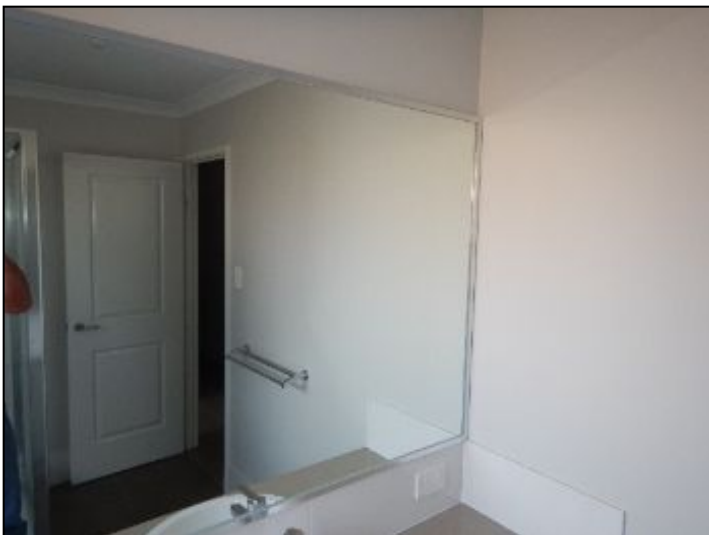
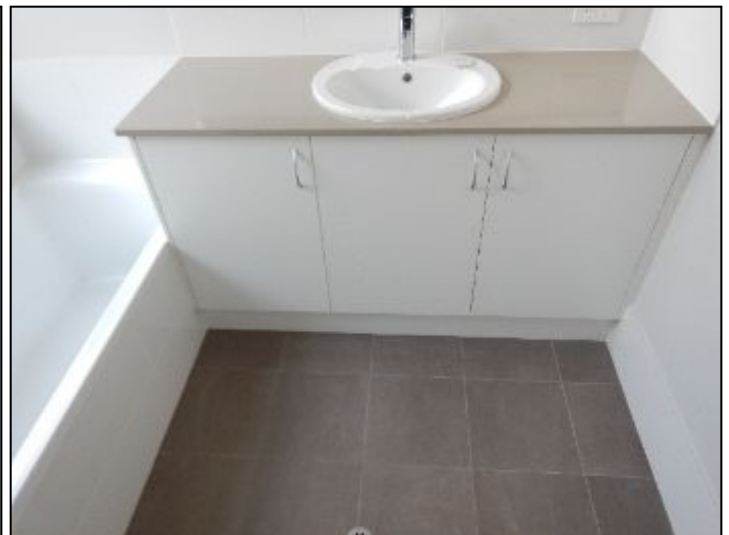
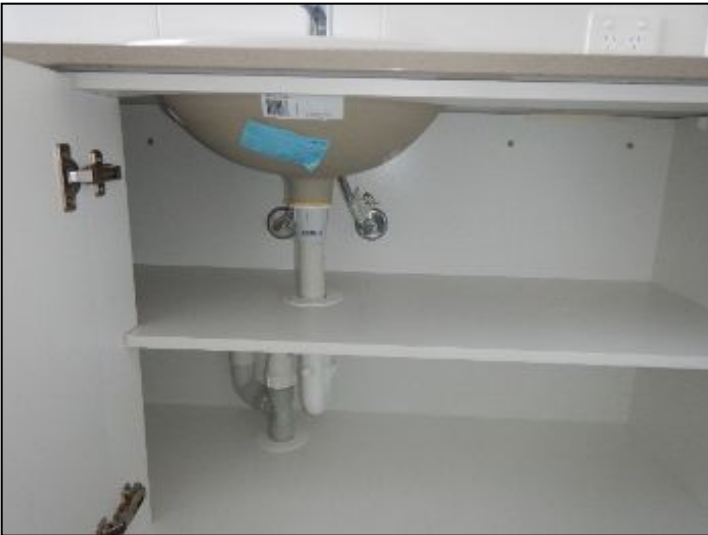
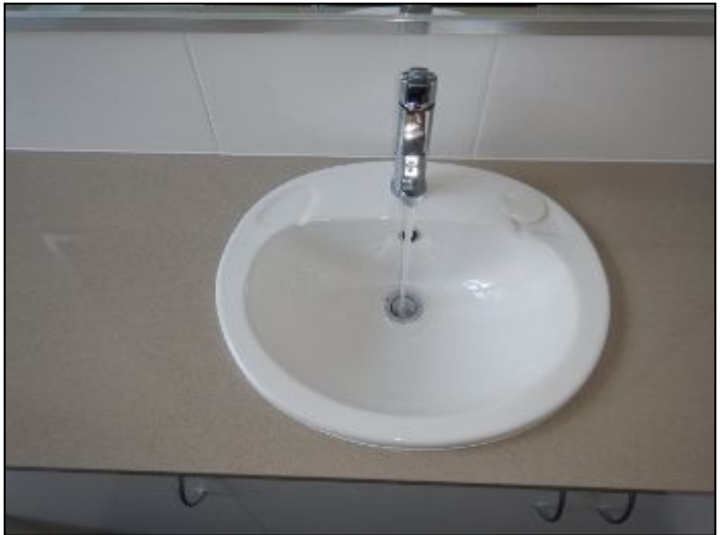
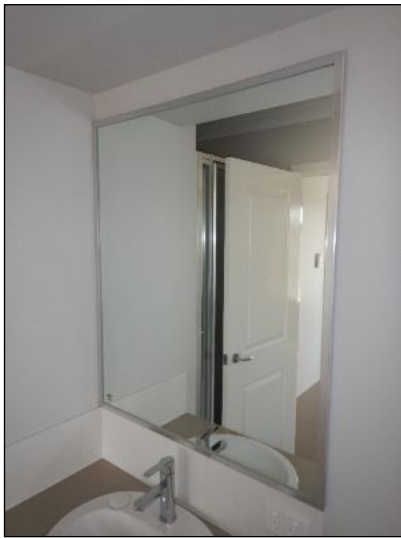
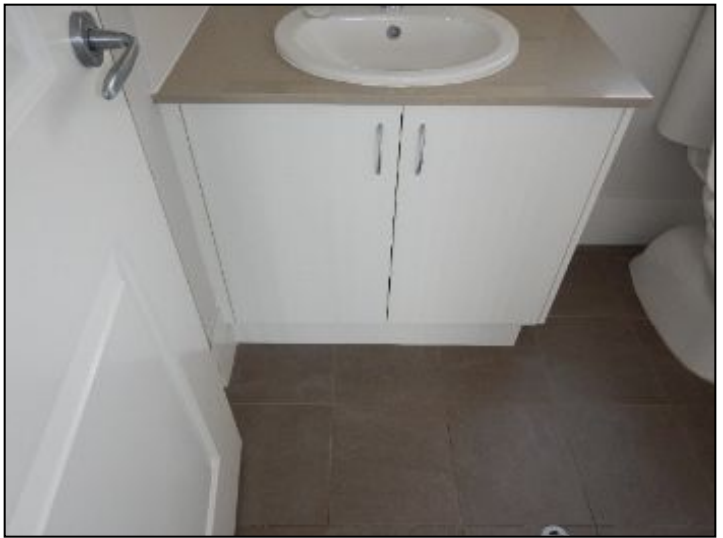
- The sink and related components were tested and appeared in a functional and in a satisfactory at time of inspection.
- Bathroom sink plumbing appeared in a functional and a satisfactory condition. No leak observed at the time of inspection.
- Bathroom cabinets appear functional and in a satisfactory condition, at time of inspection.
- Bathroom mirrors appear functional and in a satisfactory condition, at time of inspection.

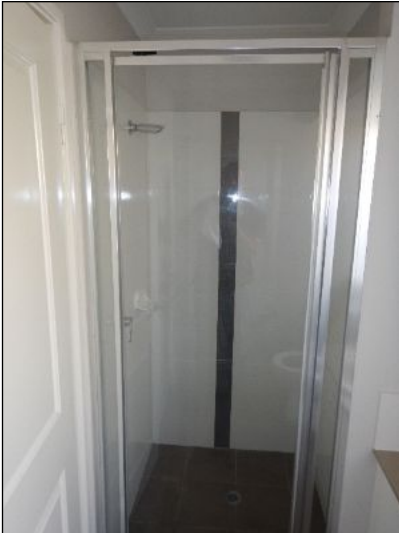
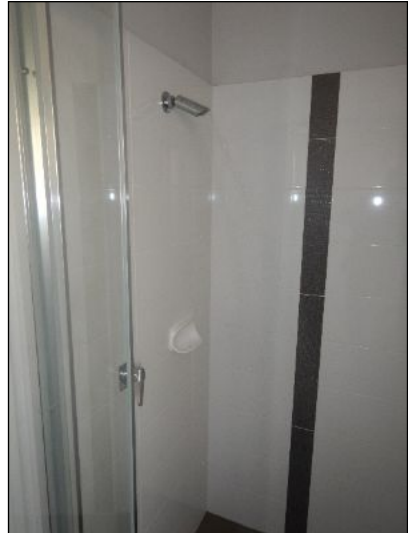
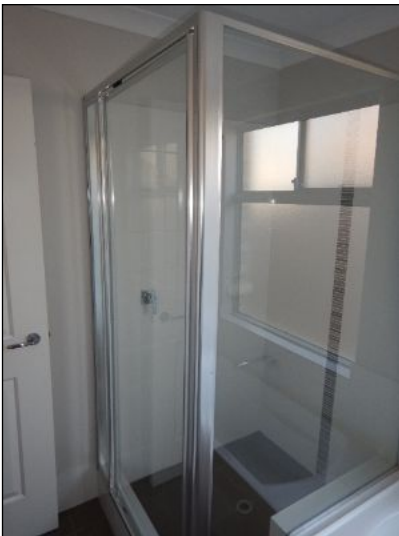
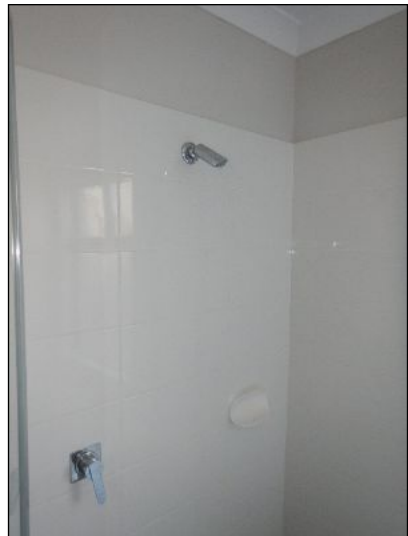
- The shower and related components were tested and appeared in a functional and in a satisfactory at time of inspection.
- The shower enclosure was functional and in a satisfactory condition at the time of the inspection.

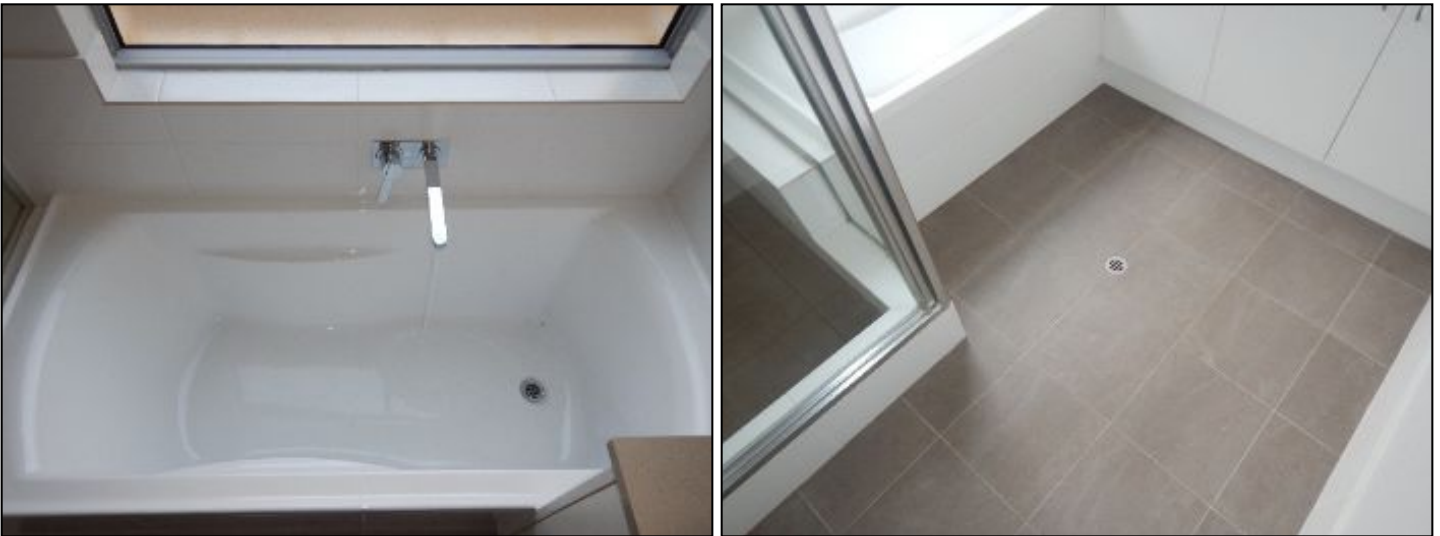
- The bath tub and related components operated normally when tested.
- Tiled Floors appear in satisfactory condition at time of inspection. No major deficiencies noted.

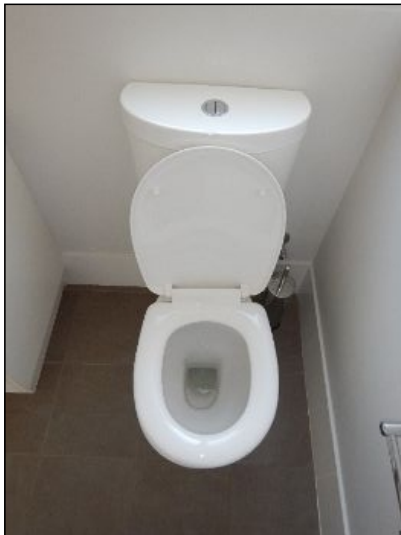
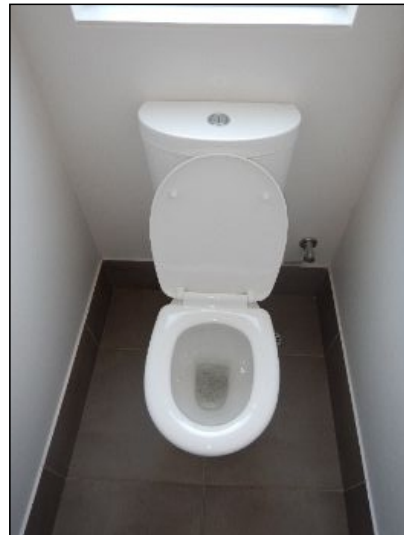
- Toilet operated normally when tested. No deficiencies noted.

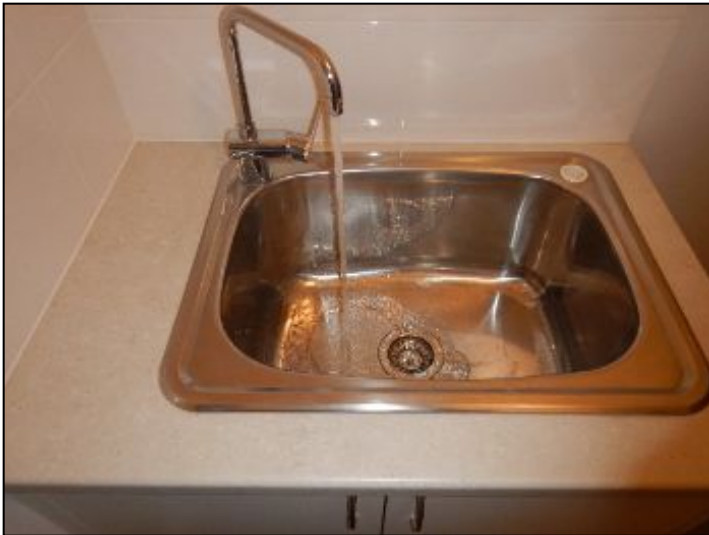
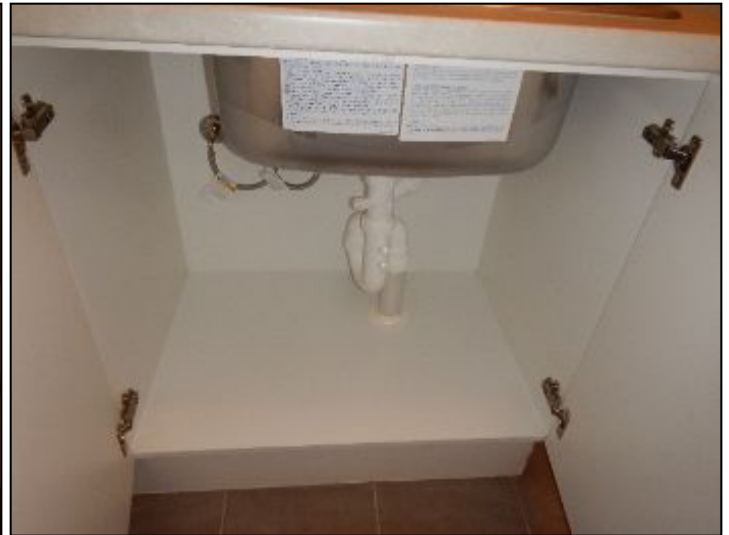
- The laundry sink appeared functional and in a satisfactory condition, at time of inspection.
- Laundry sink plumbing appeared in a functional and satisfactory condition. No leaks observed at the time of inspection.
- Laundry cabinets appears functional and in a satisfactory condition, at time of inspection.

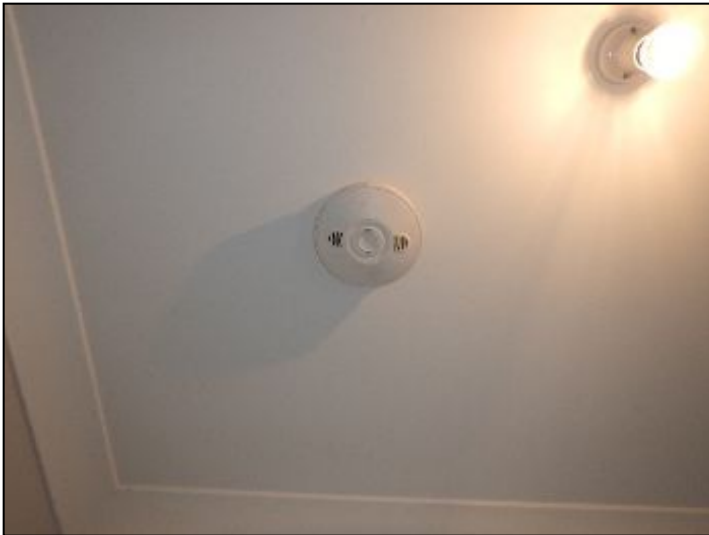
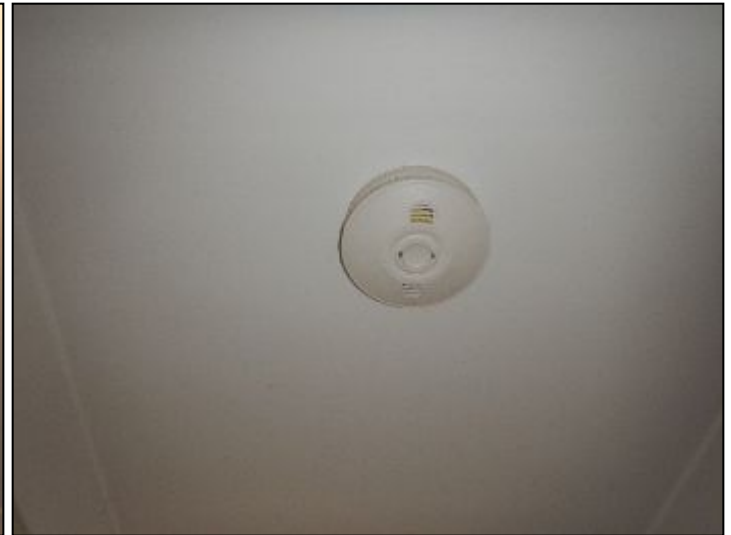
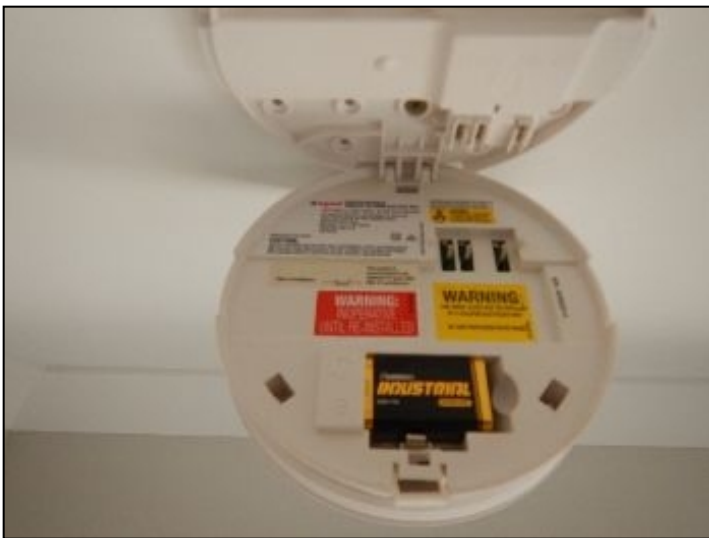
- There are 2 hard wired smoke alarms that are installed in the bedroom hallway areas.
- Smoke alarms are due for replacement in 2025.

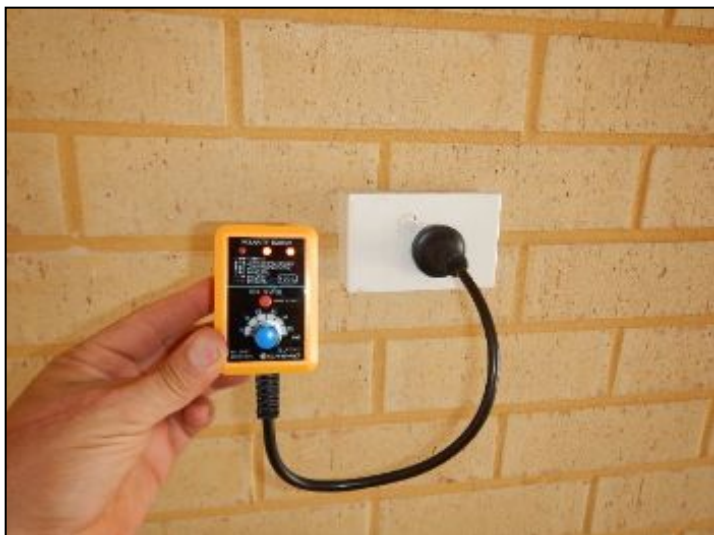
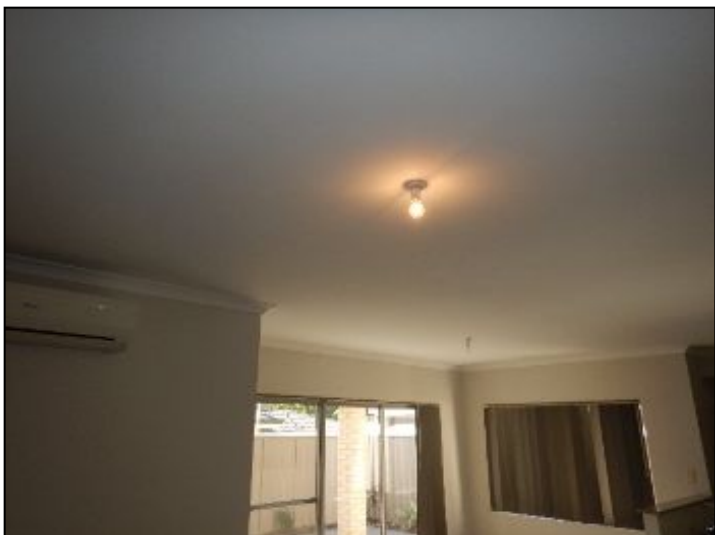
- Our inspection was limited to visible and accessible outlets only. Those outlets that were concealed or inaccessible due to stored items, furniture, etc. were not tested or inspected. Only a representative sampling of outlets were tested.
- All tested interior and exterior power points were functional and in a satisfactory at time of inspection, unless otherwise noted.
- All tested interior and exterior light fixtures and switches were functional and in a satisfactory condition at the time of inspection unless otherwise noted.

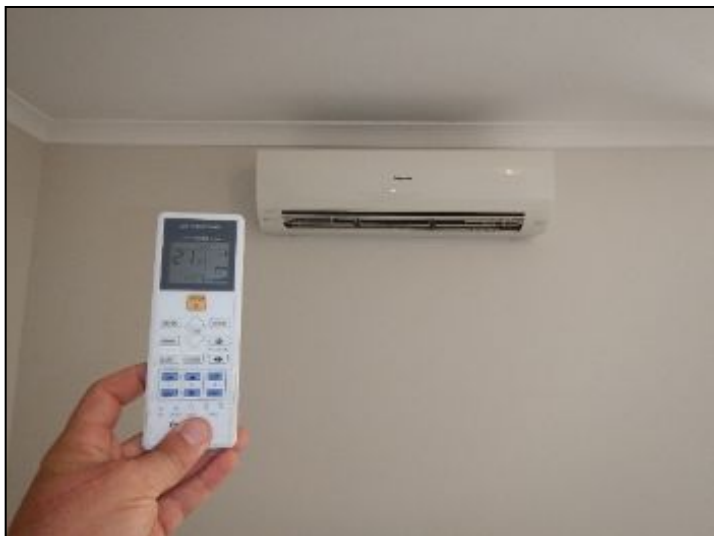
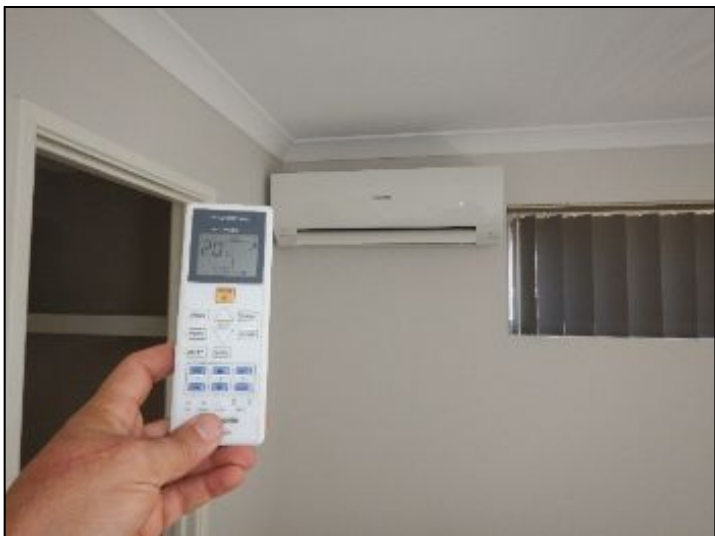
- Split system air conditioner was functional and in a satisfactory condition at time of inspection.
