Pre-Purchase Inspection Report

InspectionSmith
Property Inspections

123 Smith Street, Smithville, 6000

Date of Inspection: 29/5/2018 Time: 9:00am
Weather: Fine

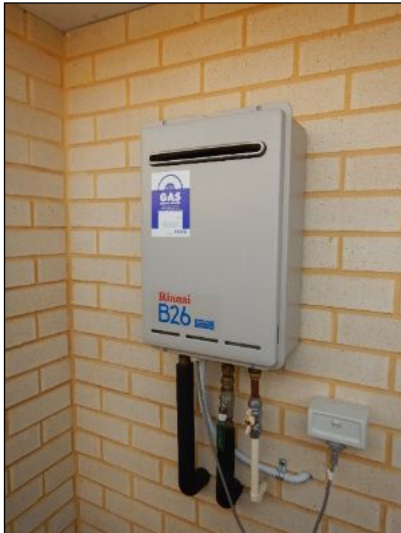
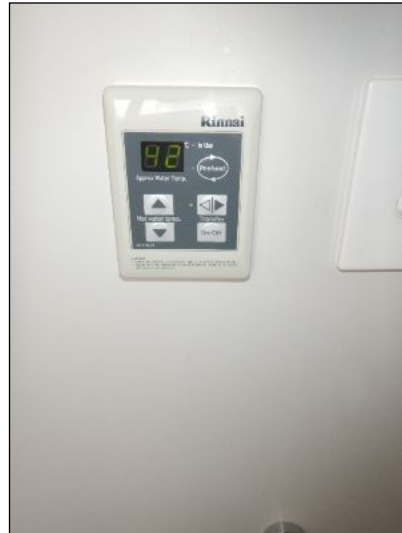
- Gas instantaneous hot water system was functional and in a satisfactory condition at time of inspection.

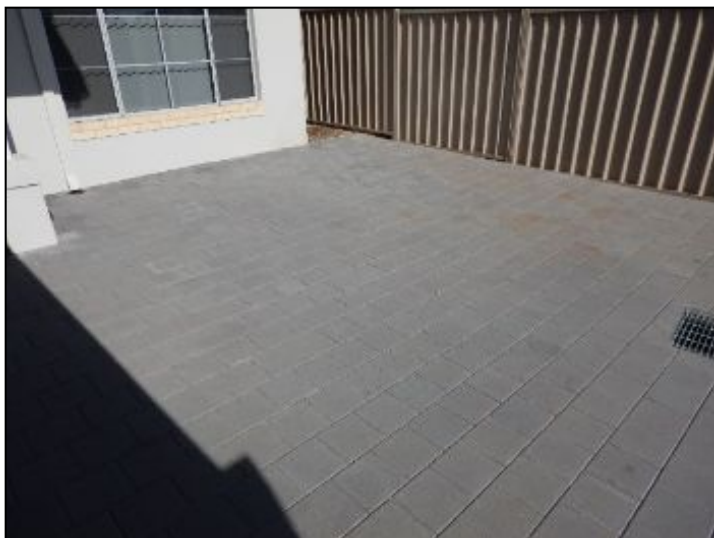
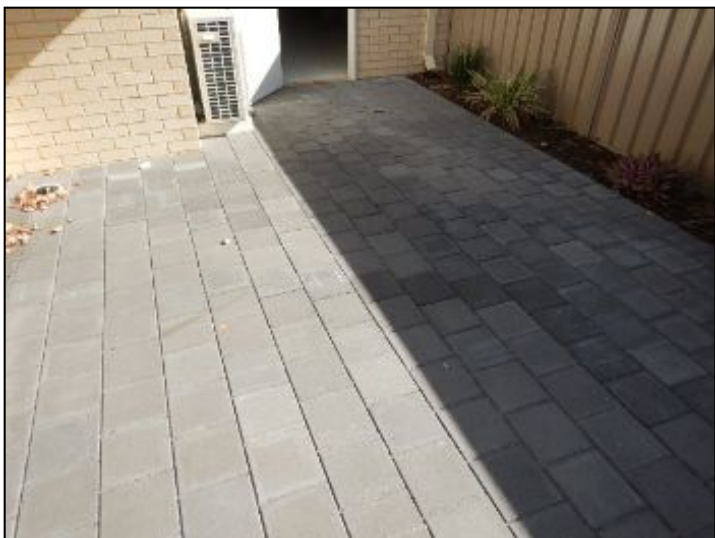
- Brick paved driveway noted and appeared functional and in a satisfactory condition at time of inspection.
- Brick paved pathway noted and appeared functional and in a satisfactory condition at time of inspection.

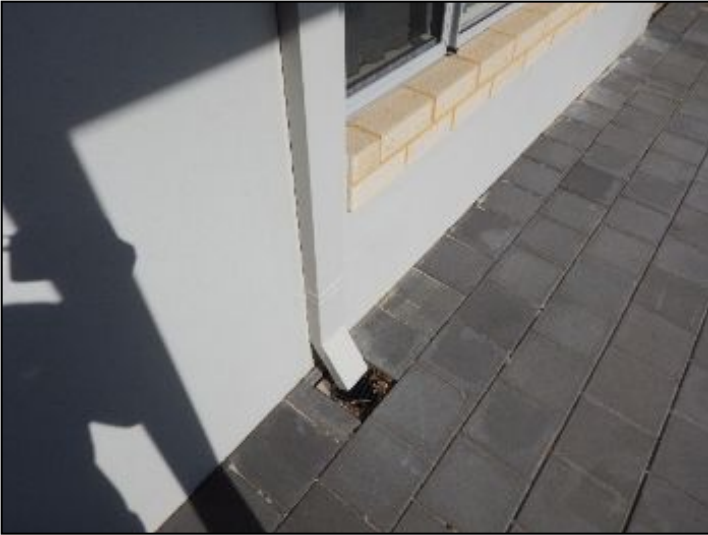
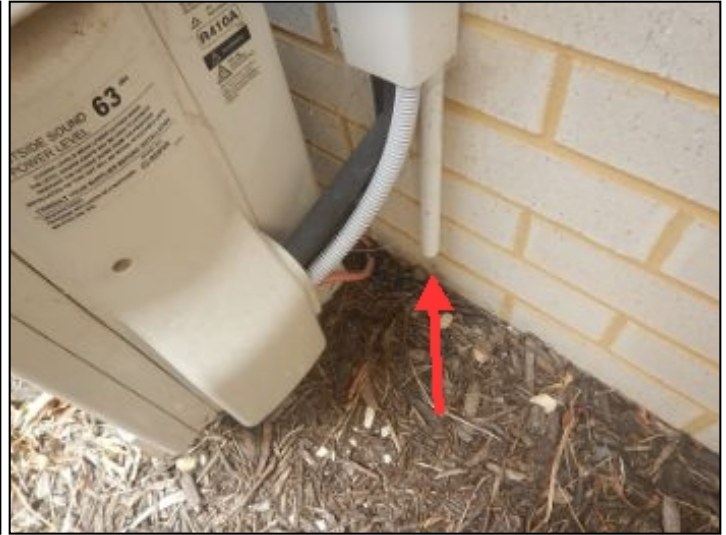
- Roof drainage conditions within 3 metres of the house appeared satisfactory.
- The air conditioner discharge pipe discharges on the foundations. This should ideally be directed into the stormwater, or at least 3 metres away from the building.

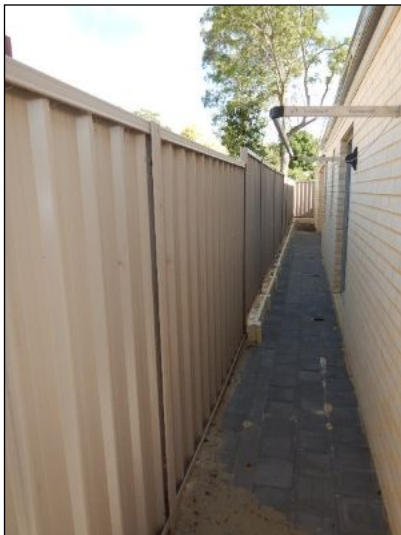
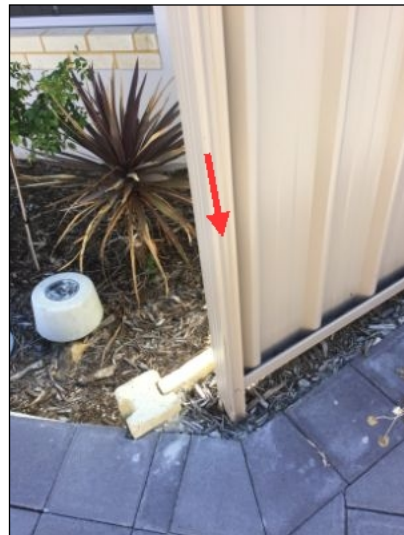
- The fence has some areas that are damaged. Some maintenance will be required to rectify.

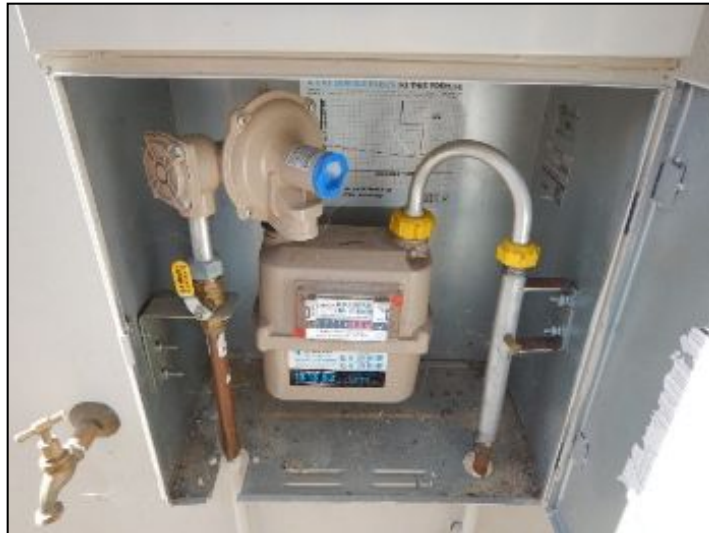
- Mains gas meter and associated plumbing appear functional and in a satisfactory condition at the time of inspection.
