Pre-Purchase Inspection Report

InspectionSmith
Property Inspections

123 Smith Street, Smithville, 6000

Date of Inspection: 29/5/2018 Time: 9:00am
Weather: Fine

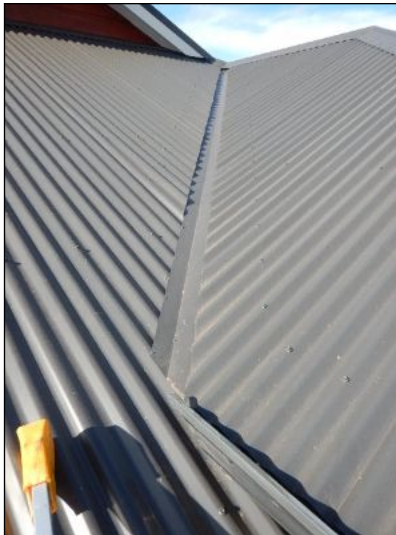
- The roof flashing, where visible, appears functional and in a satisfactory condition at time of inspection.

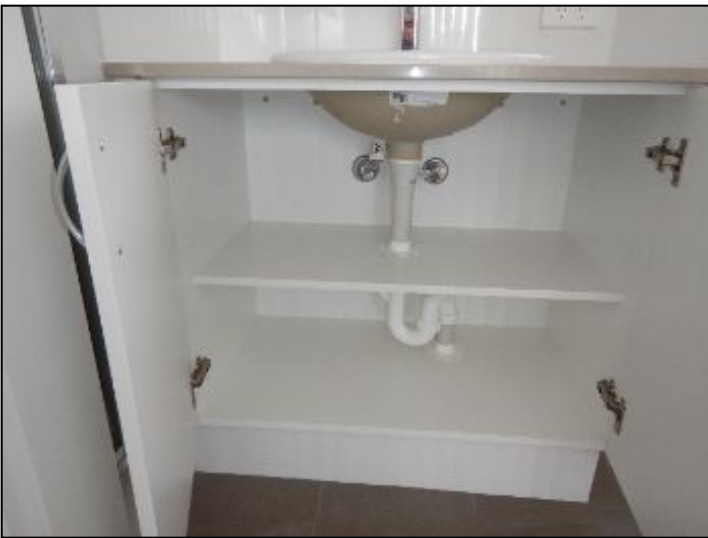
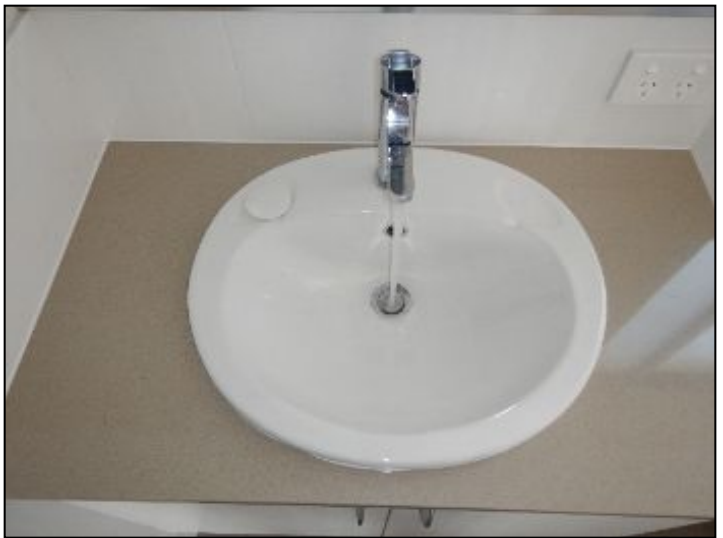
- The sink and related components were tested and appeared in a functional and in a satisfactory at time of inspection.
- Bathroom sink plumbing appeared in a functional and a satisfactory condition. No leak observed at the time of inspection.
- Bathroom cabinets appear functional and in a satisfactory condition, at time of inspection.
- Bathroom mirrors appear functional and in a satisfactory condition, at time of inspection.

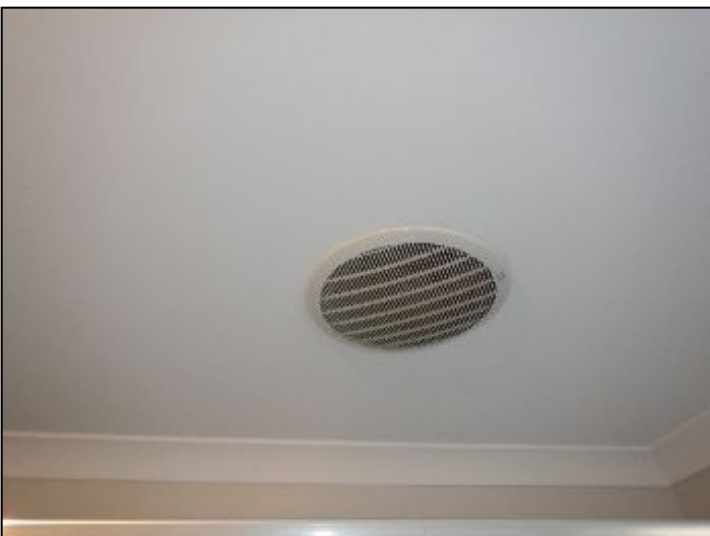
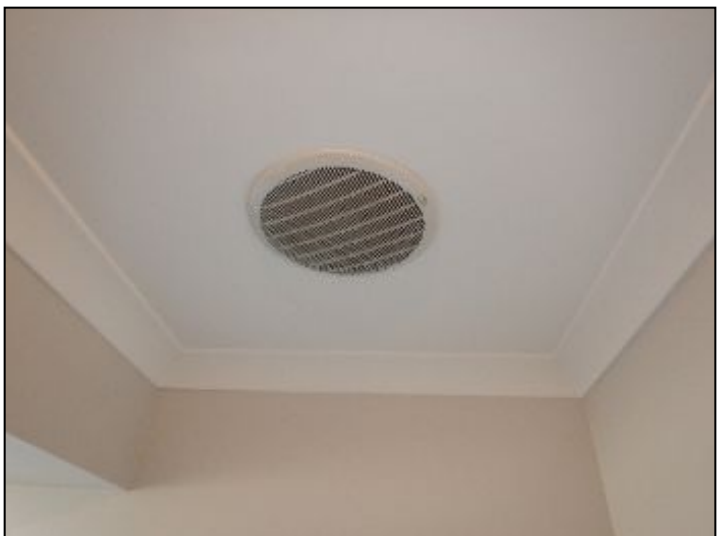
- The bathroom exhaust fan was tested and appeared to be functional and in a satisfactory time of inspection.

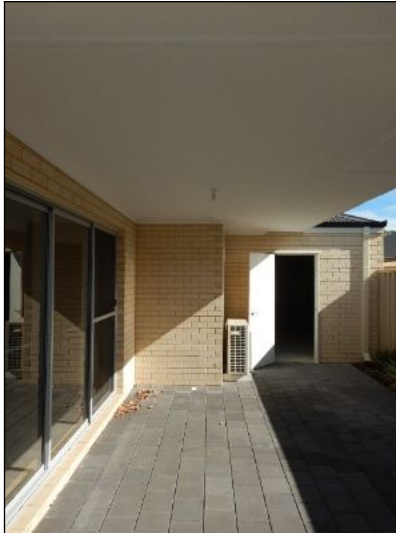
The patio/porch is part of the main structure and appears functional and in a satisfactory condition at time of inspection.

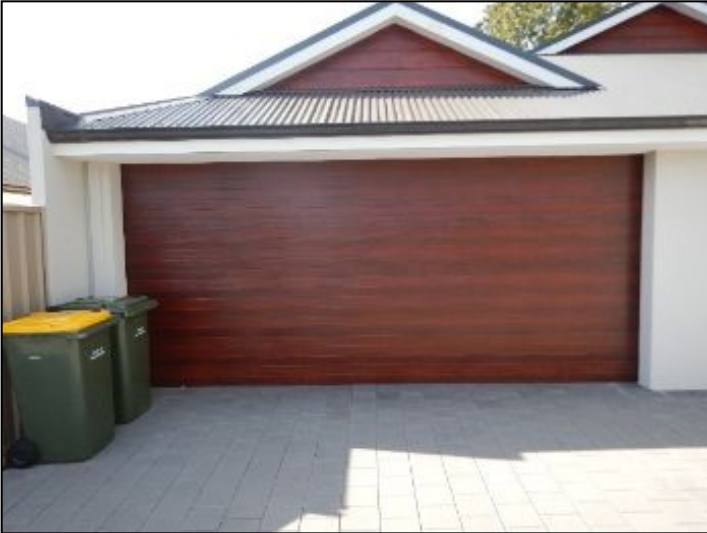
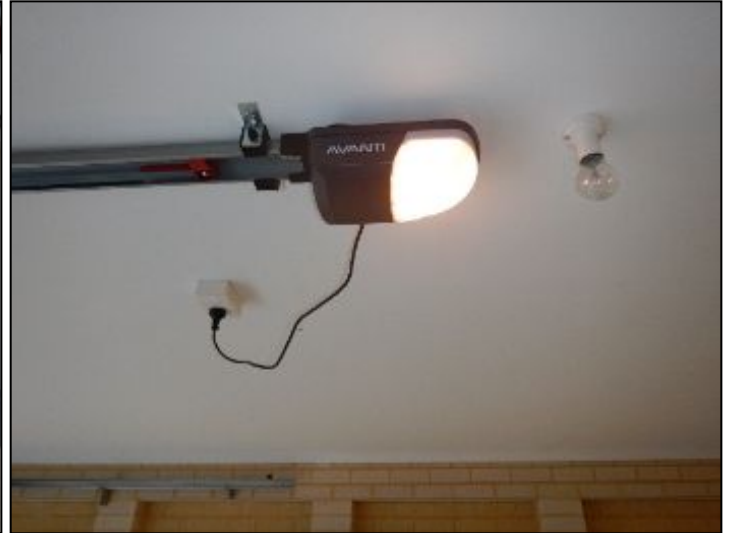
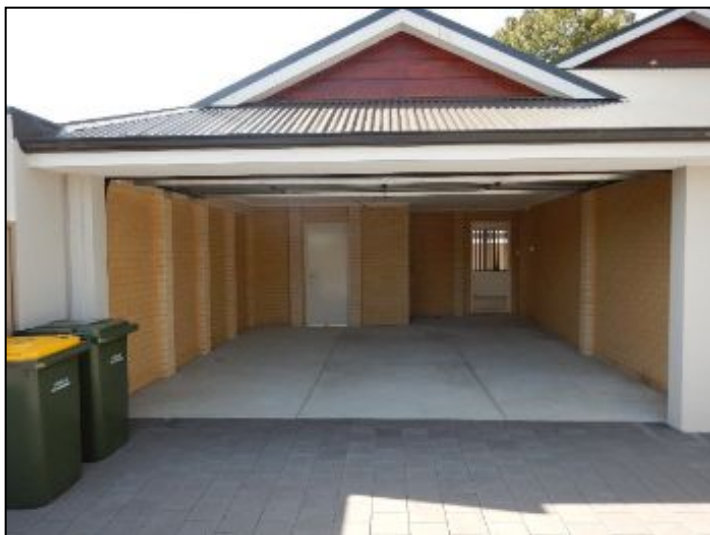
- Garage door opener operated using normal controls, at time of inspection.

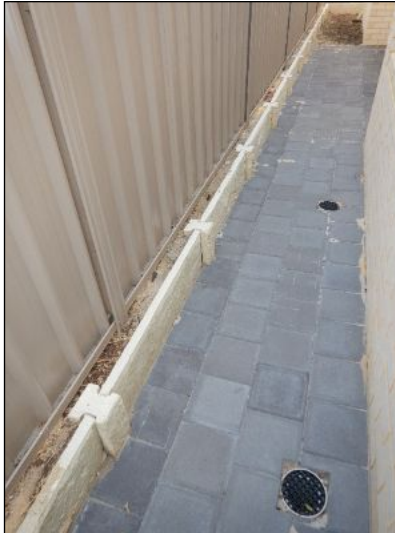
- Pre cast concrete retaining walls noted and appear functional and in a satisfactory condition at time of inspection.
